Service Bulletin

Subject: MASTER WARNING LIGHT IS ON AND INSTRUMENT CLUSTER WARNING MESSAGE IS DISPLAYED (DTC P1794 or DTC P1794 and P2502)	Bulletin No: 01-001/14
	Last Issued: 05/06/2014

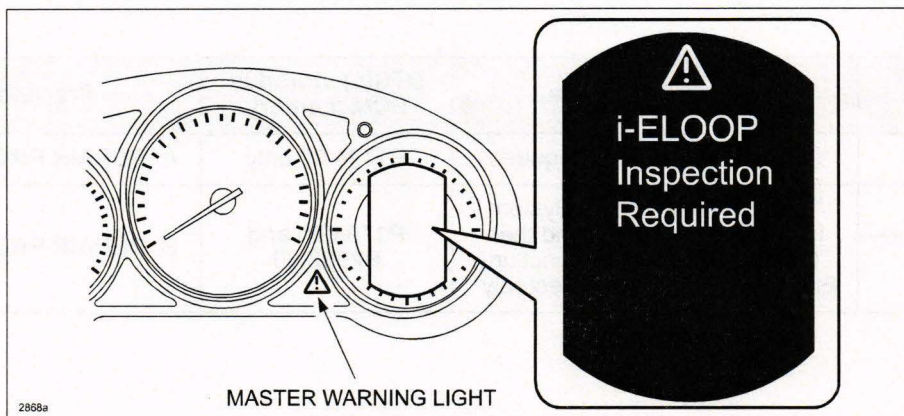
- Warning message "i-ELOOP Inspection Required" is displayed in the instrument cluster information display while driving.
- The Master warning light will be illuminated.

- DTC P1794:00 (Capacitor (i-ELOOP) system: Capacitor (i-ELOOP) malfunction) will be stored in PCM memory.

Customers having this concern should have their vehicle repaired using A. REPAIR PROCEDURE.

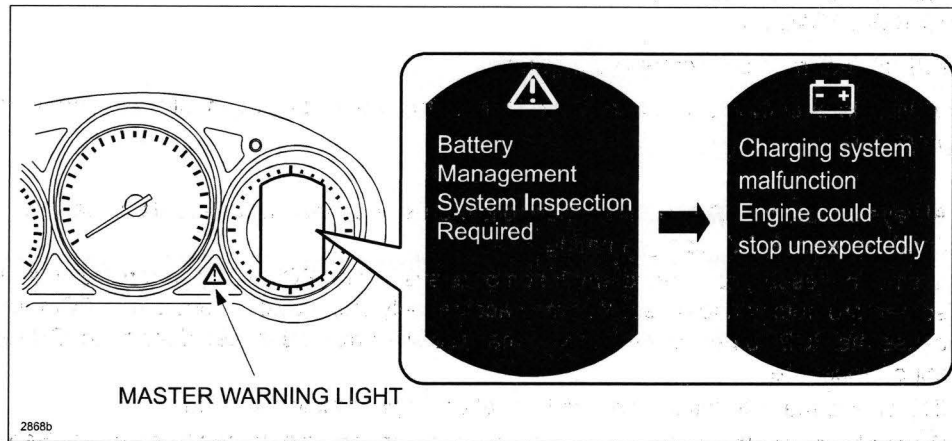
- Warning message "Battery Management System Inspection Required" and then "Charging System Malfunction/Engine could stop unexpectedly" is displayed in the instrument cluster information display after driving in the rain.
- The Master warning light will be illuminated. The Mazda6 warning indicator light and warning messages are shown below:

- The following DTCs are stored in PCM memory:
 - DTC P1794:00 - Capacitor (i-ELOOP) system: Capacitor (i-ELOOP) malfunction
 - DTC P2502:00 - Generator system: Malfunction in voltage generated by generator

Customers having this concern should have their vehicle repaired using B. REPAIR PROCEDURE.
