Aluminum Door Panel Trim Dented by Seat Belt Latchplate

YEAR(S)	MODEL(S)	ADDITIONAL INFORMATION
2013 – 2014	GS350

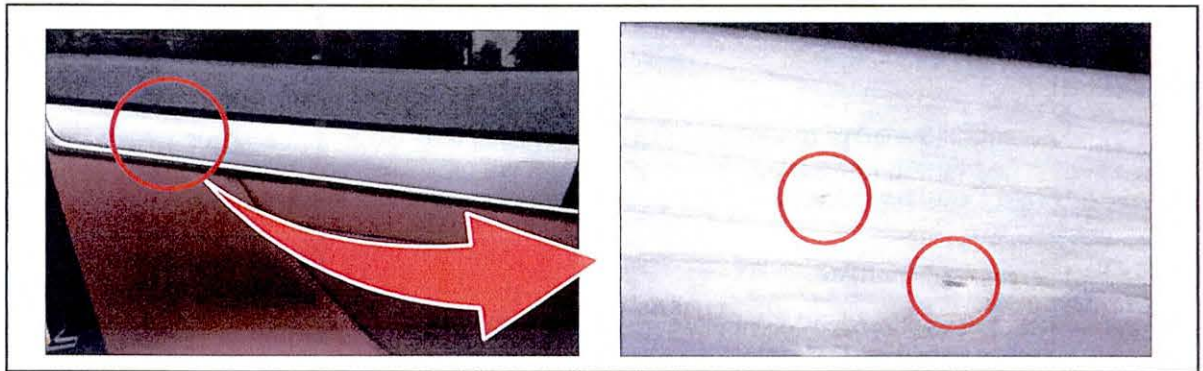
Figure 1.

Some 2013 – 2014 model year GS 350 vehicles may exhibit a condition where the door trim becomes dented during normal use (such as contact with the seat belt latchplate tang during retraction). The Front Door Trim Ornament has been updated to address this condition.

1. Confirm the condition as described in the Introduction.

2. Remove and replace the Front Door Trim Ornament.
