NUMBER: 02-008-14

GROUP: Front Suspension

Front End Clunk Noise When Coming To A Stop - Mexico Only

2011 - 2012 (LD) Dodge Charger 2011 - 2012 (LE) Dodge Charger (Export)

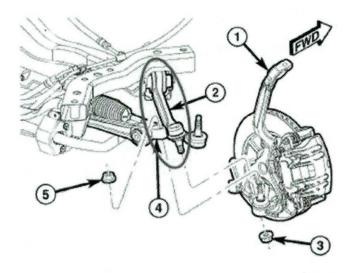
Fig. 1 Tension Strut Replacement

The customer may experience a front end clunk noise, coming from the tension strut bushing(s), when coming to a stop.

1. Replace both the left and right side tension struts. Refer to the detailed procedures available in DealerConnect>TechCONNECT> under: Service Info> 02 - Front Suspension> Front> STRUT, Tension, RWD> Removal/Installation.
