NUMBER: 07-002-14

GROUP: Cooling

Coolant Weepage At EGR Hose

Chrysler 300 (International Only)

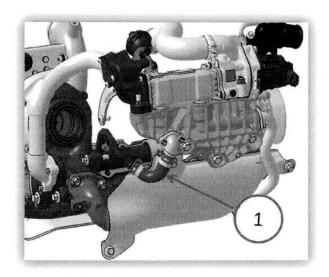
Fig. 1 EGR

The EGR hose may weep coolant.

1 - EGR Coolant Hose

- 2. Lower the belly pan splash shield.
- 3. Lower the rear transmission splash sheild.
- 4. Replace the EGR coolant hose.
