**NUMBER:** 08-007-14

Incorrect Switch Installed On The Steering Wheel

2014 (RT) Town and Country

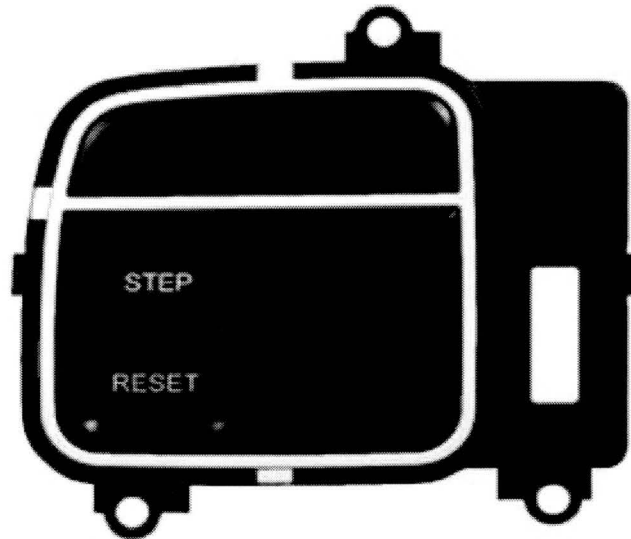
*Correct Switch*

1 - Two button switch

1. Remove the EVIC switch and install the correct part.
2. Follow the replacement procedure in DealerConnect, 08 - Electrical/8M - Message Systems/Message Center/SWITCH, EVIC Control/Removal/Installation.

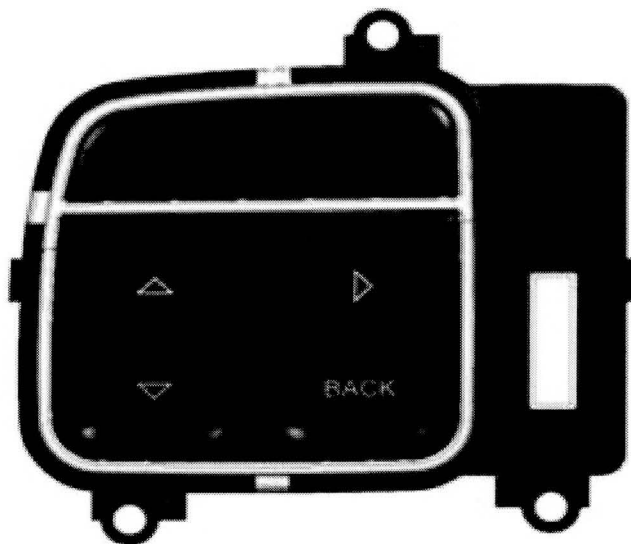
*Incorrect Switch*

Customer and or dealer may notices that the steering wheel has the incorrect switch assembly installed. The installed switch is for vehicles that are equipped with an EVIC.

1 - Four button switch
