**NUMBER:** 08-011-14

Flash: Hands Free Module Defaults To English Instead Of Last Language Selected

This Bulletin involves performing a USB service flash of the Hands Free Module (HFM).

2012- <b>**2013**</b> (JC)	Journey (International only)
2012- <b>**2013**</b> (LD)	Charger (International only)
2012- <b>**2013**</b> (LX)	300 (International only)

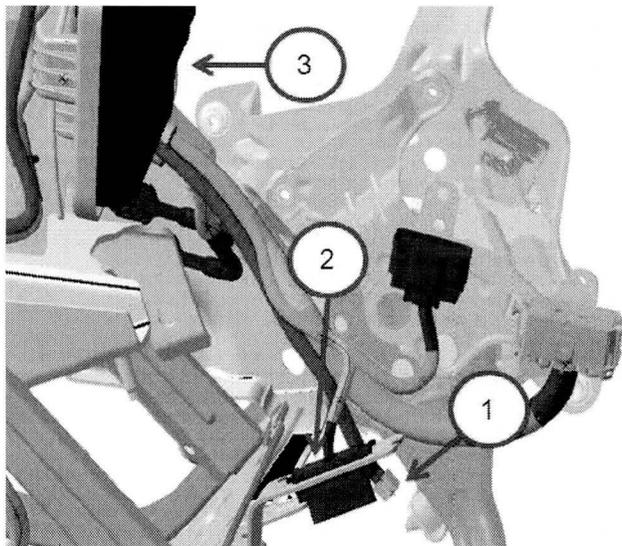
**Fig. 1 JC USB Connector Location**

- 1 - Delphi 4-Way connector (connect wiTECH USB Cable here)
  - 2 - Diagnostics Connector
  - 3 - Hands Free Module
-

**NOTE: For JC vehicles, the wiTECH cable is plugged into the Delphi 4-Way USB connector which is located next to diagnostic connector on the driver side(Fig. 1). For the LD or LX vehicles the wiTECH USB Cable is plugged directly into the HFM Module which is located above the driver's side kick panel (Fig. 2).**

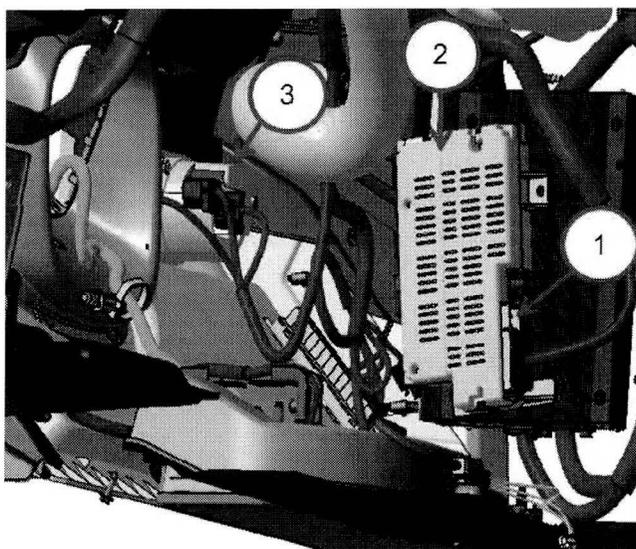
**Fig. 2 LD and LX USB Connector Location**

- 1 - USB Connector Cavity
  - 2 - Hands Free Module
  - 3 - Headlamp Switch
-

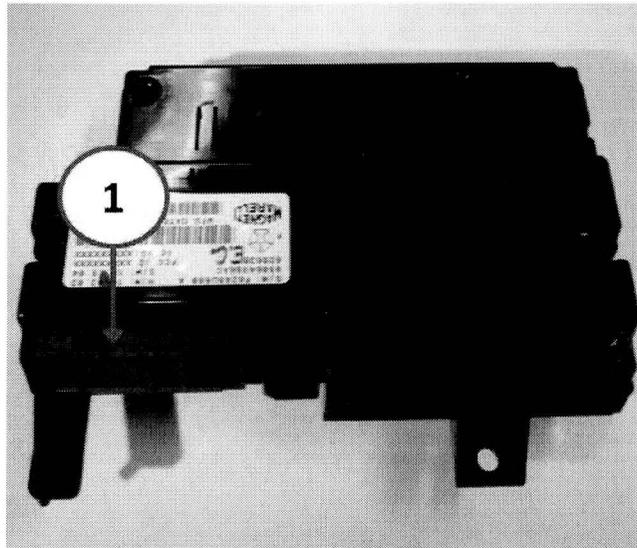
**Fig. 3 HFM Module**

1 - C1 Connector Cavity

**NOTE:** A module reset may be required in the event that an abort recovery is necessary. Procedures vary slightly between LD/LX and JC. LD/LX module power will be reset by removing the C1 connector from the HFM, see (Fig. 3). On JC vehicles, the module power will be reset by removing fuse F131 from the passenger side fuse block, see (Fig. 4).

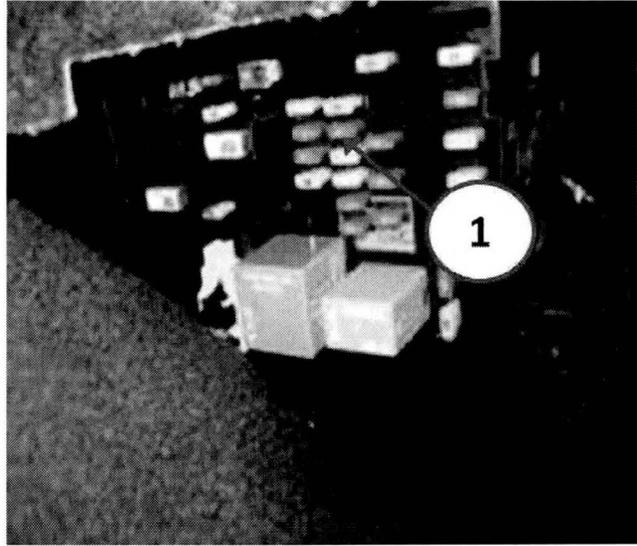
**Fig. 4 JC Passenger Side Fuse Block**

1 -Fuse F131
