NUMBER: 08-014-14

Flash: Enable Shift Up Indicator

2013 (FF) 500

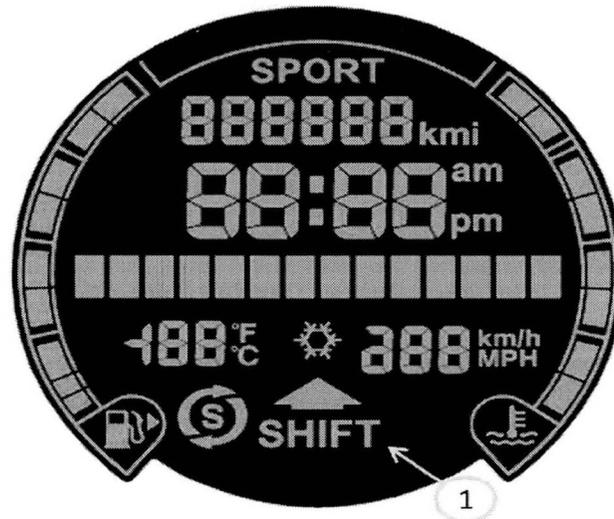
EVIC Display

The customer may notice when trying to select the Gear Shift Indicator “GSI Shift Up” in personal setting, the shift indicator doesn’t display in the EVIC.

1 - Shift Indicator

1. Update the software in the Instrument Cluster.
2. Using the wiTECH Diagnostic Application for flashing the module is made available through the wiTECH Diagnostic Application. For instructions select the "HELP" tab on upper portion of the wiTECH window, then "HELP CONTENTS." This will open the Welcome to wiTECH Help screen where help topics can now be selected.
