NUMBER: 08-028-14 REV. A

GROUP: Electrical

DATE: September 12, 2014

RE2 RE3 RE6 RB4 RB5 RB6 Radio Enhancements

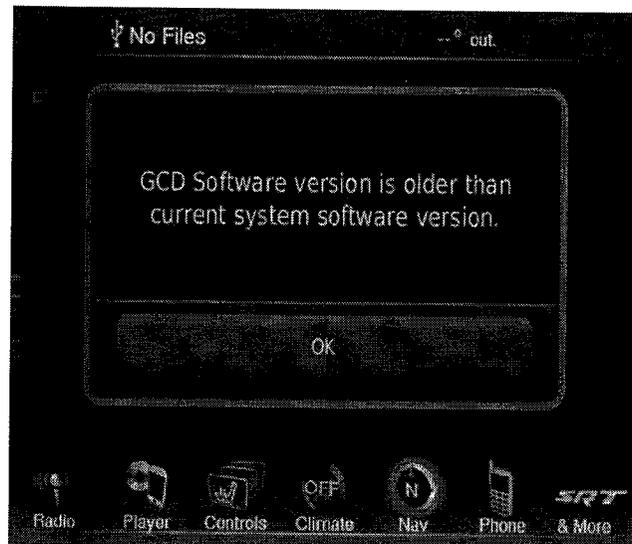
Fig. 1 Radio already has the latest software

16. Which screen does the radio display?
 - a. (Fig. 1) >>> The radio has the latest Garmin software in it, press OK and proceed to Step #20.
 - b. (Fig. 2) >>> Press Yes to update the Garmin software.
17. The first step in the update is "system recover". There will be a pop up that indicates this step. This will only take a few minutes.
18. This screen will be displayed when the update is being downloaded, see (Fig. 3).

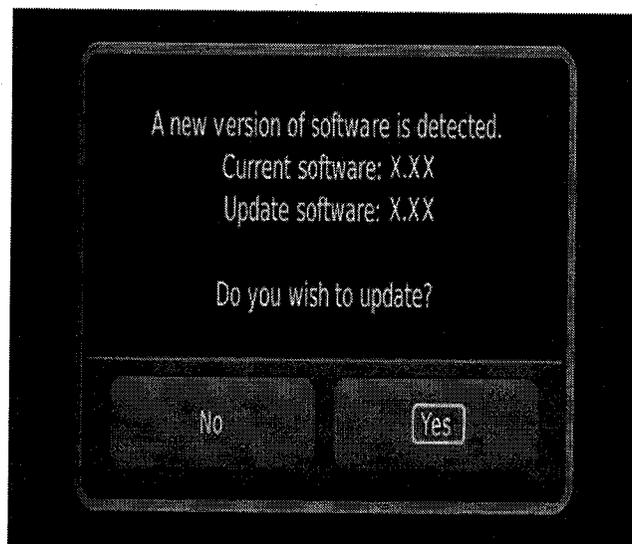
Fig. 2 Garmin software needs to be updated

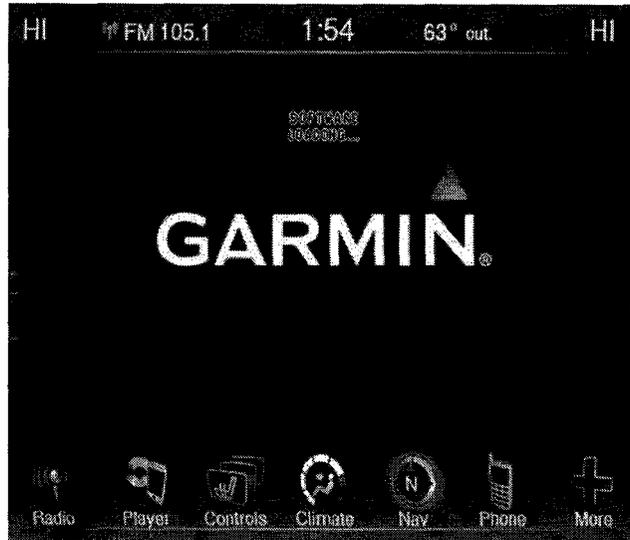
Fig. 3 This screen will be displayed next

1 - Loading software

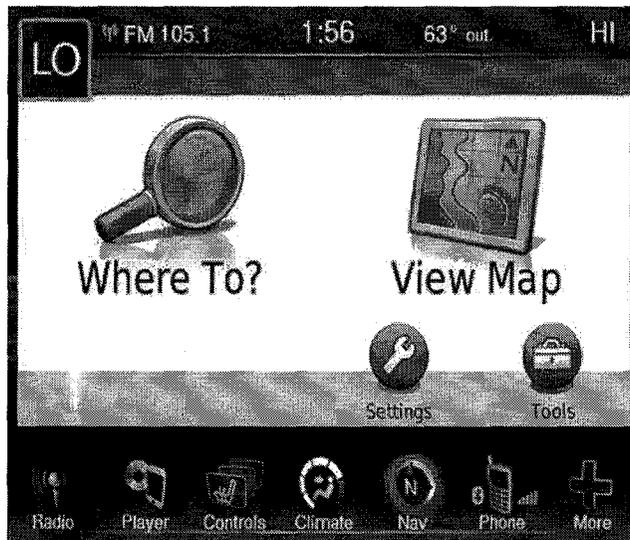
Fig. 4 Update is completed

1 - Navigation has been updated
