**NUMBER:** 08-030-14 REV. A

Flash: RE2 RE3 RE4 RE6 RE7 RB4 RB5 RB6 RB4 Radio Enhancements

This bulletin involves updating the radio's software and Navigation if required.

2013-2014	(LD)	Charger
2013-2014	(LX)	300
2013-2014	(JC)	Journey

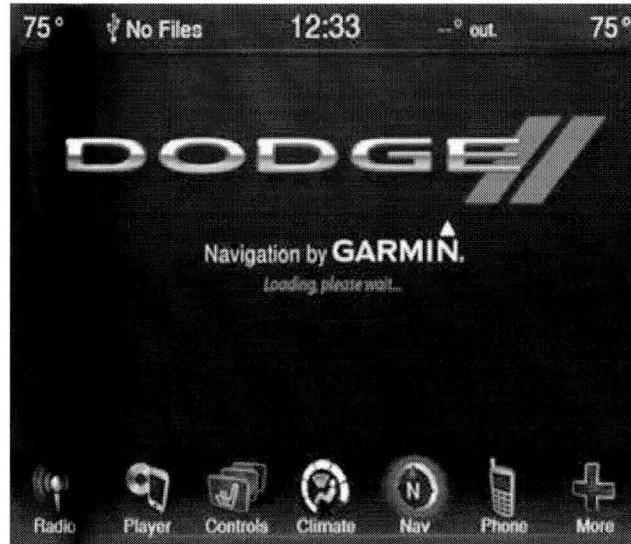
**Fig. 1 System Loading Screen**

1. Start the vehicle, turn the radio ON and allow it to power up.
2. If you have a RB4, RB5, RB6, RE4, or RE7 radio, press the navigation screen button and attempt to access the navigation main menu system.
3. Is the radio stuck on the "Loading Please Wait" screen? See (Fig. 1).

- a. Yes <<< The radio will have to be replaced. Replace the radio using current electronic exchange center stock following normal warranty repair procedures. Refer to published service information in Tech Connect Section 08 - Electrical/8E - Electronic Control Modules/MODULE, Telematics Gateway/Removal. No further action is required, the bulletin is now complete. The replacement radio will contain the latest software update.
- b. No <<< Proceed to Step #4 and perform the software update.

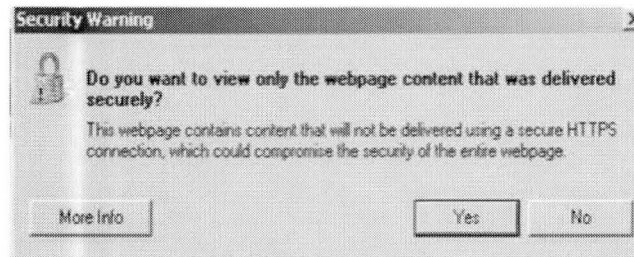
*Fig. 2 Pop-up Security Message*

- 4. Has a USB stick been created with the current software update?
  - a. Yes>>> Proceed to step Step #8.
  - b. No>>> Proceed to step Step #5.
- 5. Go to DealerCONNECT>Service>UCONNECT Information & Utilities> Uconnect Dealer software downloads to download the files.
- 6. If a securely message appears "Do you want to view only the webpage content that was delivered securely?" See (Fig. 2). Press **No** to continue.

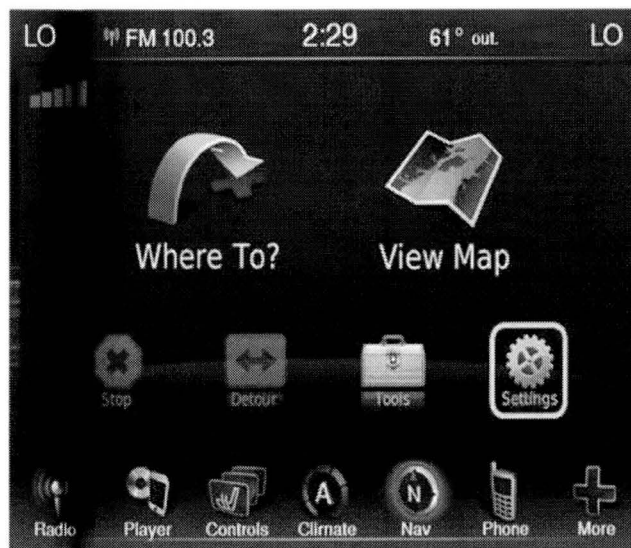
**Fig. 3 Settings Icon**

12. When the update is completed, the screen will read "Reflash Successful". Touch the screen and the radio will reboot.
13. The screen will now show the current and new software levels. Verify if the new and current software levels are now the same and press no on the screen.
14. Remove the USB stick from the USB port and proceed to Step #15.
15. Does this vehicle have one of the following radios, RE2, RE3, RE6 or RE7?
  - a. Yes <<< Only the radio control head needs to be updated, this bulletin is now complete.
  - b. No <<< The Garmin navigation system update needs to be performed, proceed to Step #16.
16. From the navigation main menu screen, press the Settings screen button. See (Fig. 3).

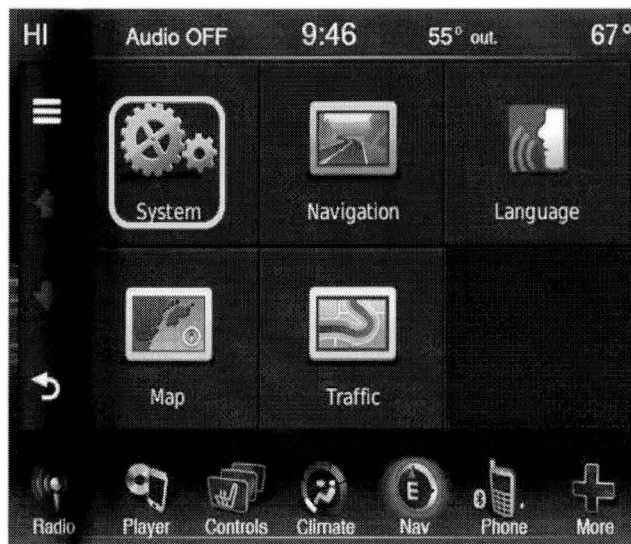
**Fig. 4 System Icon**

17. Press the System Icon. See (Fig. 4).

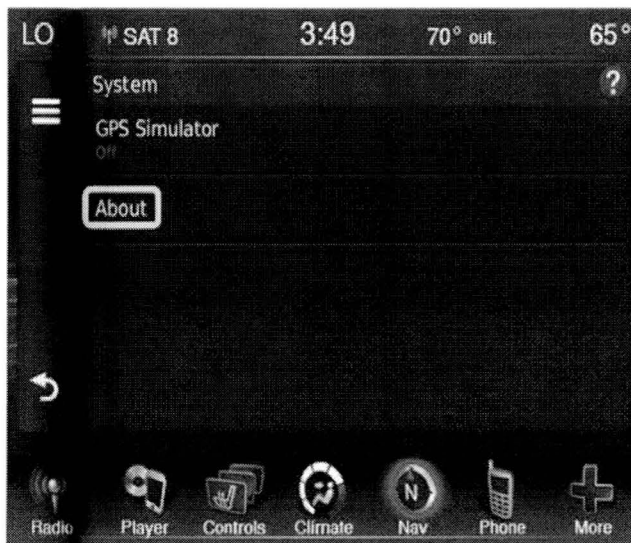
**Fig. 5 About Icon**

18. Press the About screen icon, See (Fig. 5), and record the software version.

19. For **2013** Model Year vehicles, is the software version 4.30 or earlier?
  - a. Yes <<< Proceed to Step #21 and perform the update.
  - b. No <<< The Garmin Navigation system is already up to date. The bulletin is now complete.
20. For **2014** Model Year vehicles, is the software version 5.12 or earlier?
  - a. Yes <<< Proceed to Step #21 and perform the update.
  - b. No <<< The Garmin Navigation system is already up to date. The bulletin is now complete.
21. Insert the correct USB stick containing the Garmin Navigation update into the USB port.
22. The radio screen will now display one of two pop up screen see (Fig. 6) or (Fig. 7)

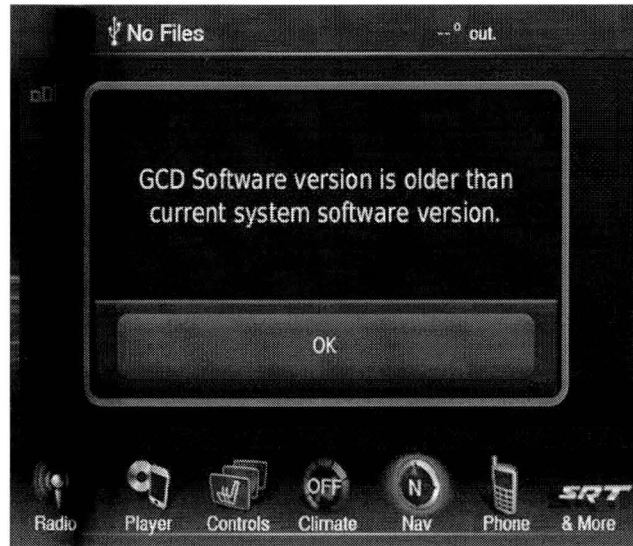
**Fig. 6 Garmin Software Already Updated**

23. Which screen does the radio currently display?
  - a. (Fig. 6) <<<The radio has the latest Garmin software installed. Press OK and proceed to Step #27.
  - b. (Fig. 7) <<<Press Yes to continue and proceed with the Garmin software update.
24. The first step in the update is "system recover". There will be a pop up that indicates this step along with a progress bar. This will only take a few minutes.
25. This next screen will be displayed when the update is being down loaded, see (Fig. 8).

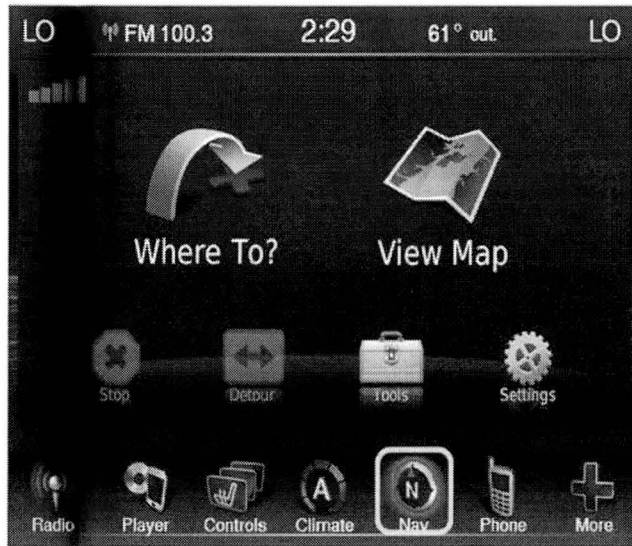
**Fig. 9 Update Complete**

26. When the software has completed down loading, the screen will change to the Garmin main screen, see (Fig. 9)

27. Remove the USB stick and cycle the key. The bulletin is now complete.
