**NUMBER:** 08-030-14

RB5 RE2 RB6 RE3 RE6 RE4 RE7 RE9 Radio Enhancements

This bulletin involves updating the radio's software and Navigation if required.

2013	(LD)	Charger
2013	(LX)	300
2013	(JC)	Journey

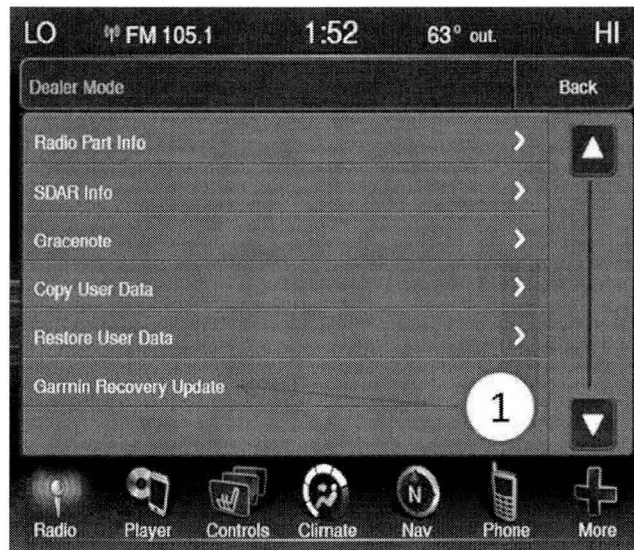
**Fig. 1 Press Garmin Recovery Update to begin update**

1 - Press soft key to begin

6. When the update is completed, the screen will read "Reflash Successful". Touch the screen and the radio will reboot.
7. The screen will now show the old and new software, press "No" on the screen to eject the disc.
8. Does this vehicle have one of the following radios, RE2, RE3, RE6 or RE7?
  - a. Yes <<< Only the radio control head needs to be updated, this bulletin has been completed.
  - b. No <<< Navigation updates needs to be performed, proceed to Step #9.
9. Put the radio into dealer mode by press the drives Temp up and down and the front defrost all at the same time until the dealer mode screen is displayed.
10. Press the soft key "Garmin Recovery Update" to begin the navigation update, see (Fig. 1).

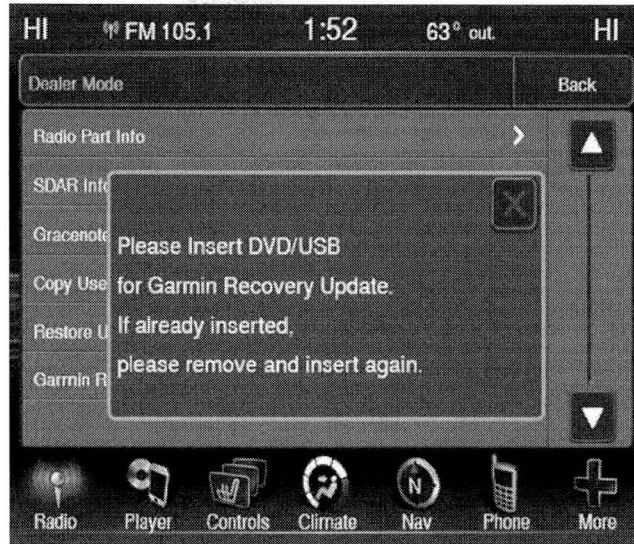
**Fig. 2 Insert update when this screen is displayed**

1 - Insert the update disc into the CD drive

- 
11. To update the navigation system, insert the correct navigation update disc into the CD drive, when this pop up is displayed. see (Fig. 2).

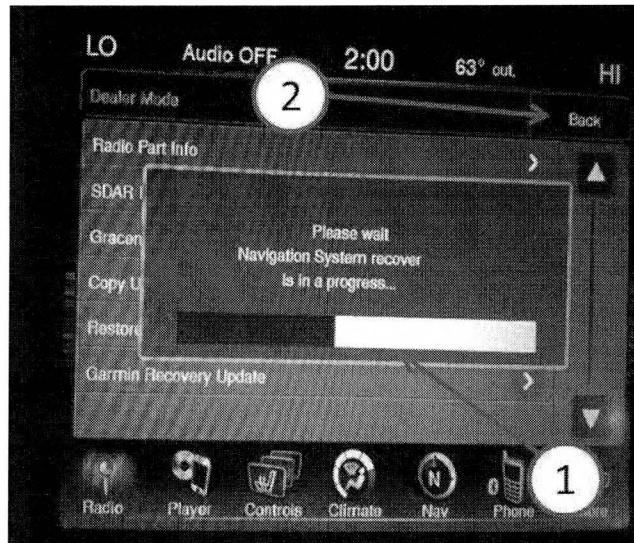
**Fig. 3 This screen will be displayed next**

- 1 - Pop up
  - 2 - Soft key, back button
-

- 12. Navigation system recover, is the first step in the update. When this part is done the pop up will no longer be displayed. This will only take a few minutes.
- 13. To continue press the “Back” soft key in the upper left hand corner of the screen (Fig. 3).

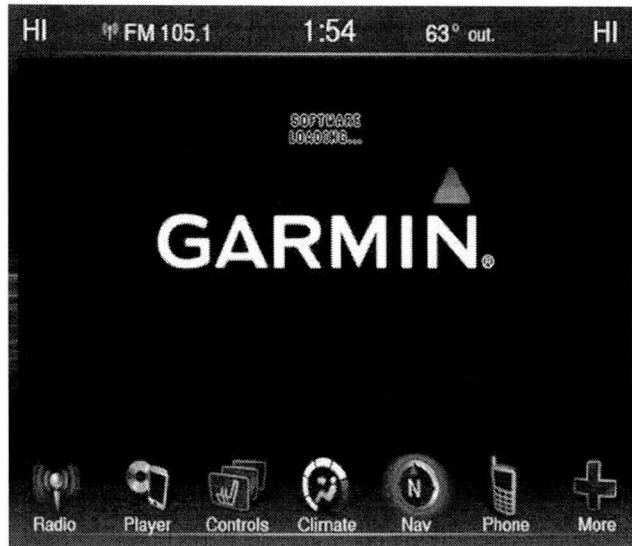
**Fig. 4 This screen will be displayed next**

1 - Loading software

14. This screen will be displayed when the update is being down loaded, see (Fig. 4).

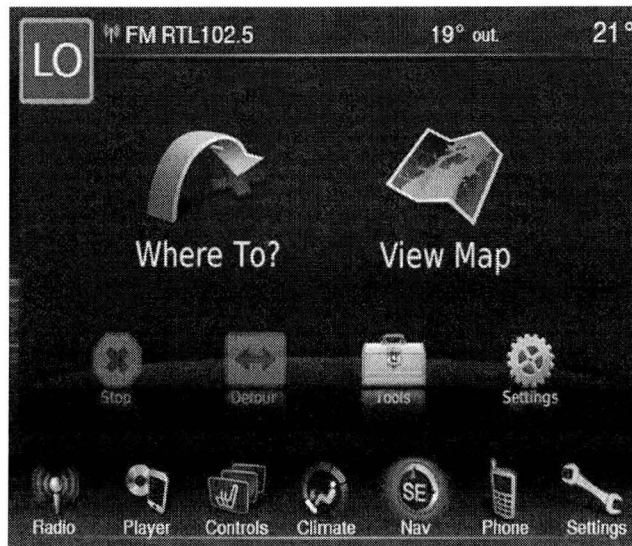
**Fig. 5 Navigation Down Load Completed**

1 - Navigation software has been updated

15. When the software has completed down loading, the screen will change to the Garmin main screen, see (Fig. 5).
