NUMBER: 08-037-14 REV. A

Flash: RB4 Radio Enhancements

This bulletin involves updating the radio and navigation software, if required.

2013	(LD)	Charger (International only)
2013	(LX)	300 (International only)
2013	(JC)	Journey (International only)

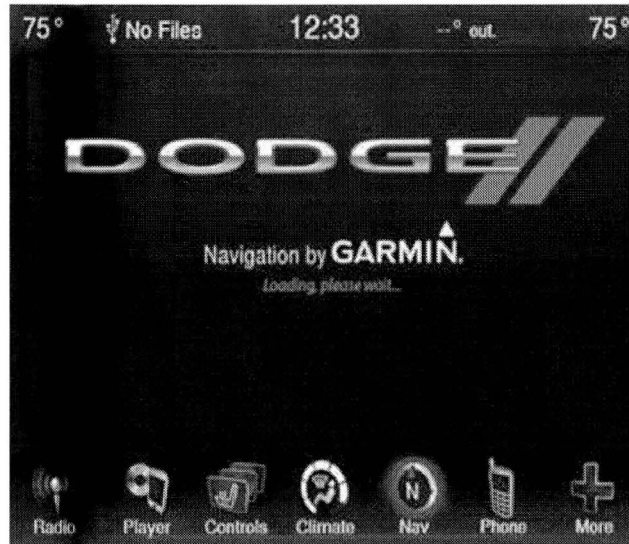
Fig. 1 System Loading Screen

3. Is the radio stuck on the "Loading Please Wait" screen? See (Fig. 1).
 - a. Yes <<< The radio must be replaced. Replace the radio using current electronic exchange center stock following normal warranty repair procedures. Refer to published service information in Tech Connect Section 08 - Electrical/8E - Electronic Control Modules/MODULE, Telematics Gateway/Removal. No further action is required, the new radio will have the updated software. The bulletin is now complete. Use Labor Op 18-60-02-CB to close out the RRT portion of this bulletin.
 - b. No <<< Proceed to Step #4 and perform the software update.

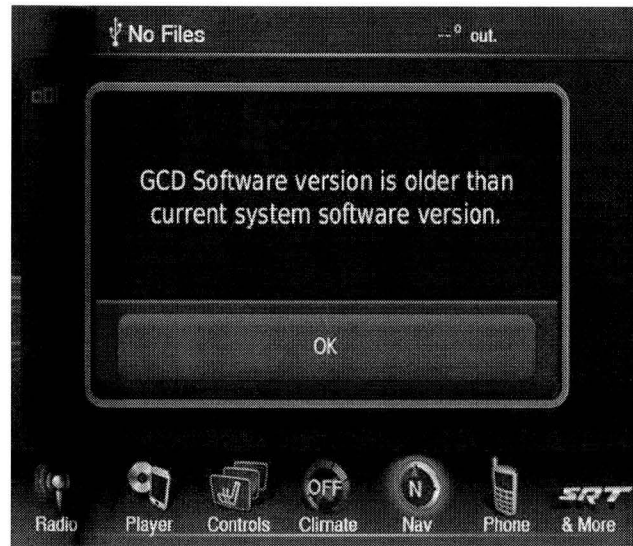
Fig. 6 Garmin Software Already Updated

21. Which screen does the radio currently display?
 - a. (Fig. 6) <<< The radio has the latest Garmin software installed. Press OK and proceed to Step #25.
 - b. (Fig. 7) <<< Press Yes to continue and proceed with the Garmin software update.
22. The first step in the update is "system recover". There will be a pop up that indicates this step along with a progress bar. This will only take a few minutes.
23. This next screen will be displayed when the update is being down loaded, see (Fig. 8).
