**NUMBER:** 08-037-14

**GROUP:** Electrical

RB4 Radio Enhancements

This bulletin involves updating the radio and navigation software, if required.

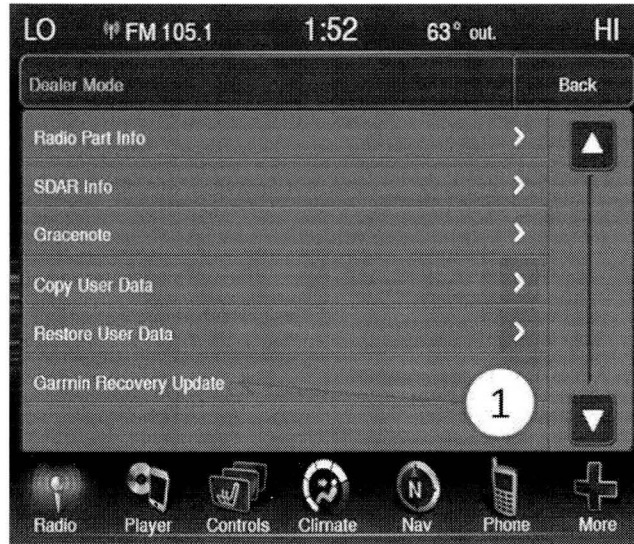
**Fig. 1 Press Garmin Recovery Update to begin update**

1 - Press soft key to begin

6. When the update is completed, the screen will read "Reflash Successful". Touch the screen and the radio will reboot.
7. The screen will now show the old and new software, press "No" on the screen to eject the disc.
8. Put the radio into dealer mode by press the drives Temp up and down and the front defrost all at the same time until the dealer mode screen is displayed.
9. Press the soft key "Garmin Recovery Update" to begin the navigation update, see (Fig. 1).

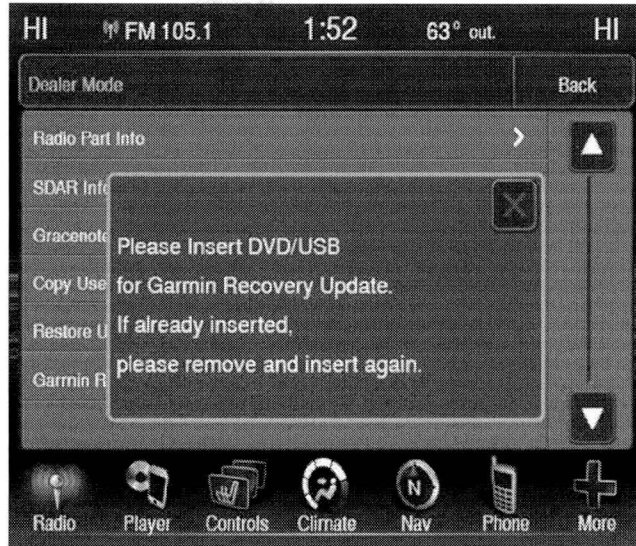
**Fig. 2 Insert update when this screen is displayed**

1 - Insert the update disc into the CD drive

- 
10. To update the navigation system, insert the disc into the CD drive(Fig. 2).

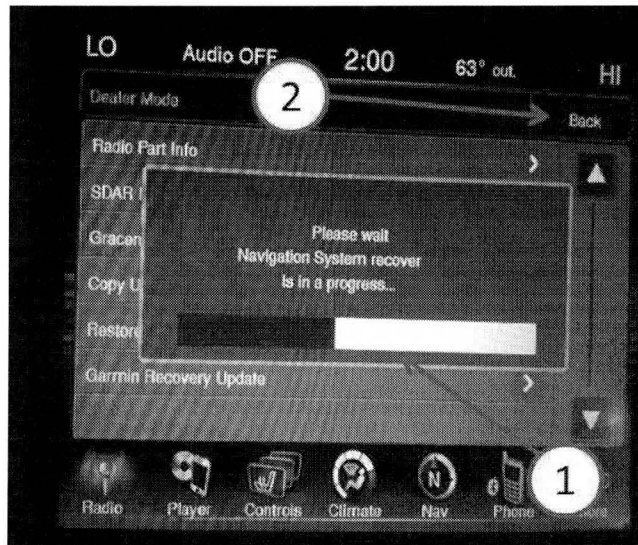
**Fig. 3 This screen will be displayed next**

- 1 - Pop up
  - 2 - Soft key, back button
-

- 
11. This is the first step in the update, System recover. When this part is done the pop up will no longer be displayed. This will only take a few minutes.
  12. To continue press the "Back" soft key in the upper left hand corner of the screen (Fig. 3).

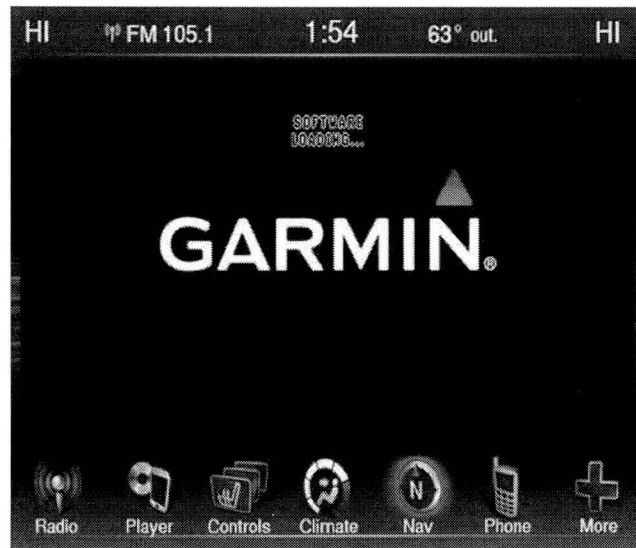
**Fig. 4 This screen will be displayed next**

1 - Loading software

13. This screen will be displayed when the update is being down loaded, see (Fig. 4).

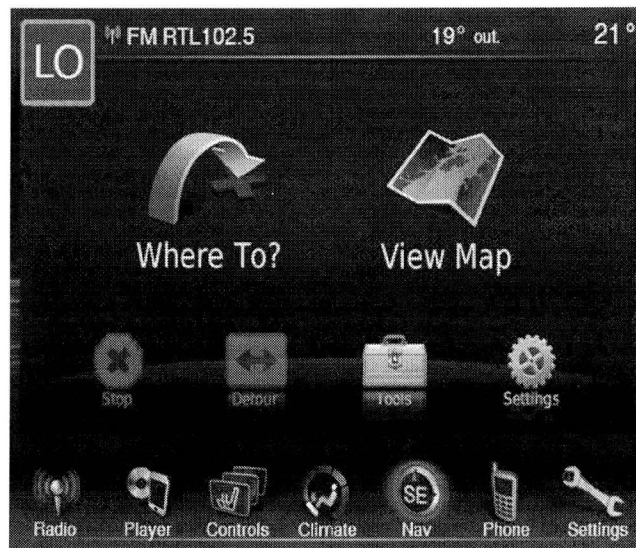
**Fig. 5 Update has been completed**

1 - Navigation has been updated

14. When the software has completed down loading, the screen will change to the Garmin main screen, see (Fig. 5).
