NUMBER: 08-040-14 REV. A

Police Vehicle A/C Inoperative

This bulletin involves relocating the A/C fuse within the front Power Distribution Center (PDC).

2011-**2013** (LD)

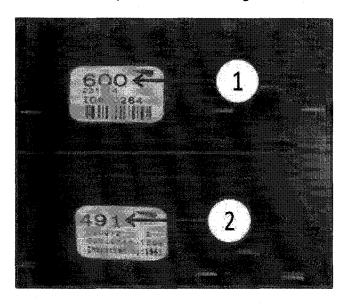
Fig. 1 PDC Identification Numbers

2. **Check the PDC identification number. Late built PDCs do **Not** have this issue, see (Fig. 1).**

- 3. **Is the PDC identification number 491 (early built)?
 - a. Yes >>> Perform this repair procedure, proceed to Step #4.
 - b. No >>> This bulletin does not pertain, normal diagnostics should be performed.**
