Topic	Flying Spur HVAC refrigeration pipe clip replacement - Corrosion (SC14/02)
Market area	Russische Föderation (5RU), Russian Federation 935 Volkswagen Group RUS (6935), United Kingdom E01 Bentley UK (6E01), Germany E02 Bentley rest Europe (6E02), Japan E03 Bentley Japan (6E03), Australia E04 Bentley rest Asia and Australia (6E04), United States E05 Bentley USA and rest America (6E05), United Arab Emirates E06 Bentley Middle East and Africa (6E06)
Brand	Bentley
Transaction No.	2035328/2
Campaign number	EA02
Note	
Type	Workshop Campaign
US code

Workshop Campaign EA02

Flying Spur HVAC refrigeration pipe clip replacement - Corrosion (SC14/02)

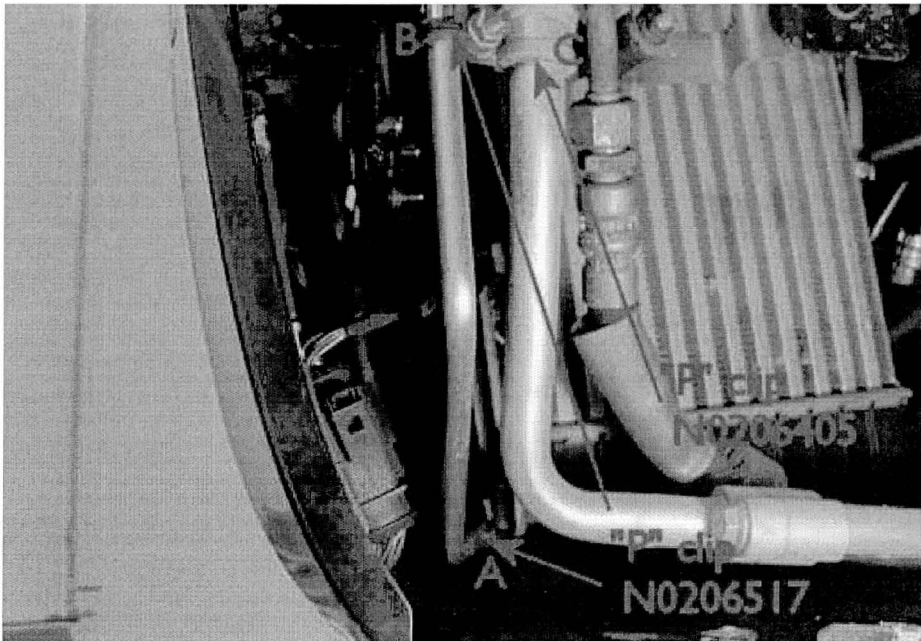
5. Referencing figure 1 identify the three P clips (A,B and C) located in the front left wheelarch that require replacement

6. Using a T30 bit loaded into a ratchet spanner remove the fastener securing P clip (A). Remove and discard clip A (see Figure 1 and 2)
7. Remove and discard clips B and C (see Figure 1)

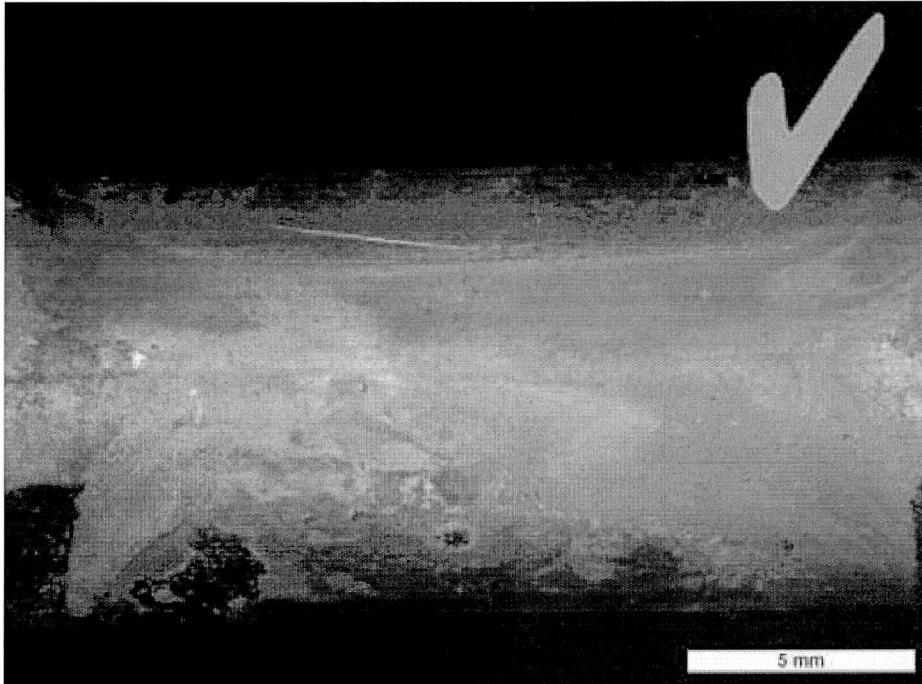
Figure 3

corrosion, use of a mirror will aid inspection. Discolouration and light oxidation on the surface of the pipe is not detrimental and does not necessitate pipe replacement (see Figure 3). If the pipe surface shows signs of extensive corrosion and pitting (see Figure 4) then that pipe should be replaced

9. On cars where the pipe is serviceable, figure 3, fit three replacement clips. For position A and B fit new clip part number RSGUV1.10-15W1 in position C fit new clip part number RSGUV1.18-15W1. If either pipe is found to have extensive corrosion then both pipes should be replaced before replacing the clips, in this case follow the *Air conditioning pipe replacement* procedure detailed below.

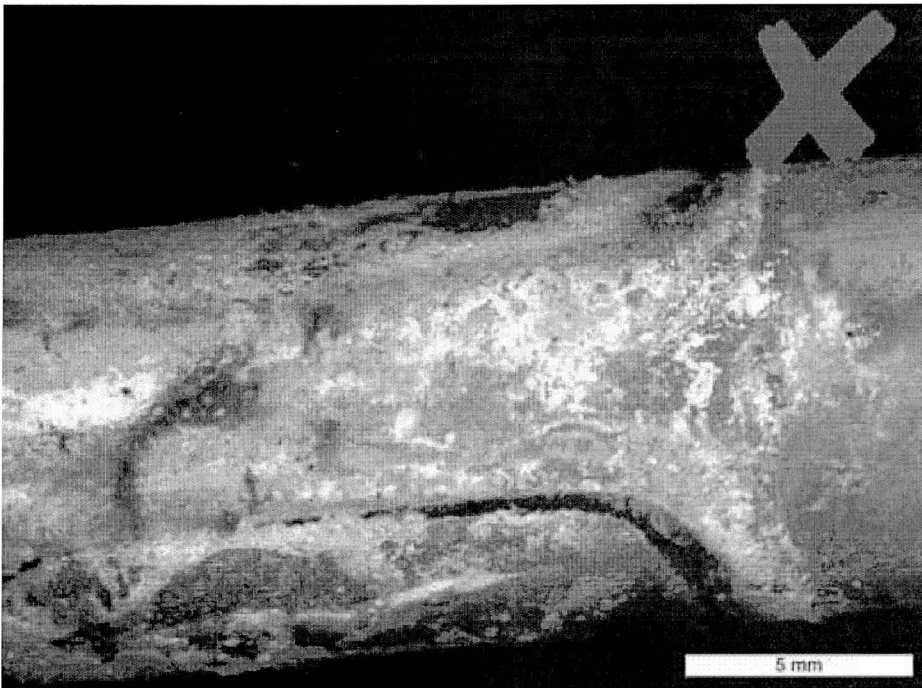
Figure 4

Extended durability trials have identified corrosion on the outside of the air conditioning pipe where it passed through the left hand front wheel arch area. This corrosion is only evident at the clipping point and is associated with the use of stainless steel clips. In extreme cases the corrosion would compromise the pipe integrity and result in refrigerant loss.

1. This procedure is only to be performed if either pipe has extensive surface corrosion at the clipping points (see Figure 4)
2. **Note:** If the refrigeration system is left open for more than 30 minutes the accumulator will have to be replaced
1. Discharge the refrigerant from the system Rep. Gr.87 Refrigeration system – To discharge and charge
