Topic	Water ingress – hood stowage area - high mounted stop lamp
Market area	Worldwide Bentley (1WBE)
Brand	Bentley
Transaction No.	2035817/1
Level	EH
Status	Approval
Release date

Transaction No.: 2035817/1

Water ingress – hood stowage area - high mounted stop lamp

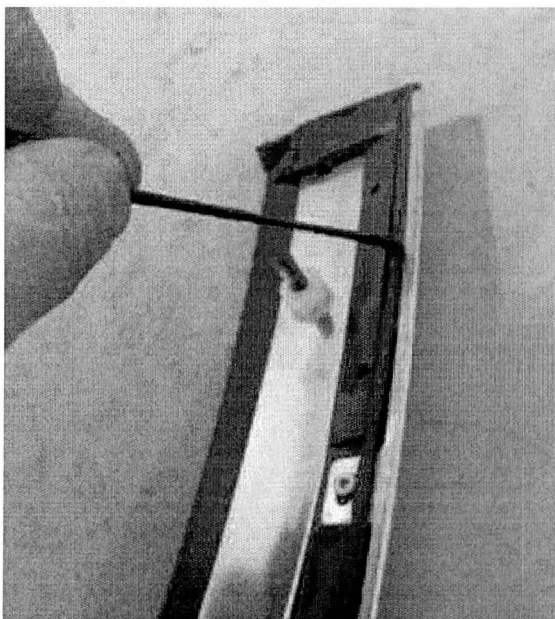
Figure 1

Seal failure between the brightware containing the high mounted stop lamp, and the tonneau cover, can lead to water ingress into the hood stowage area

2. Remove the original seal and thoroughly clean the surface on which the new seals will be positioned (see Figure 1)
