Topic	W12 Engine and Transmission control module update (SC14/01)
Market area	Worldwide Bentley (1WBE)
Brand	Bentley
Transaction No.	2036134/2
Campaign number	EA01
Note	
Type	
US code

New Continental Series and Flying Spur

W12 Engine and Transmission control module update (SC14/01)

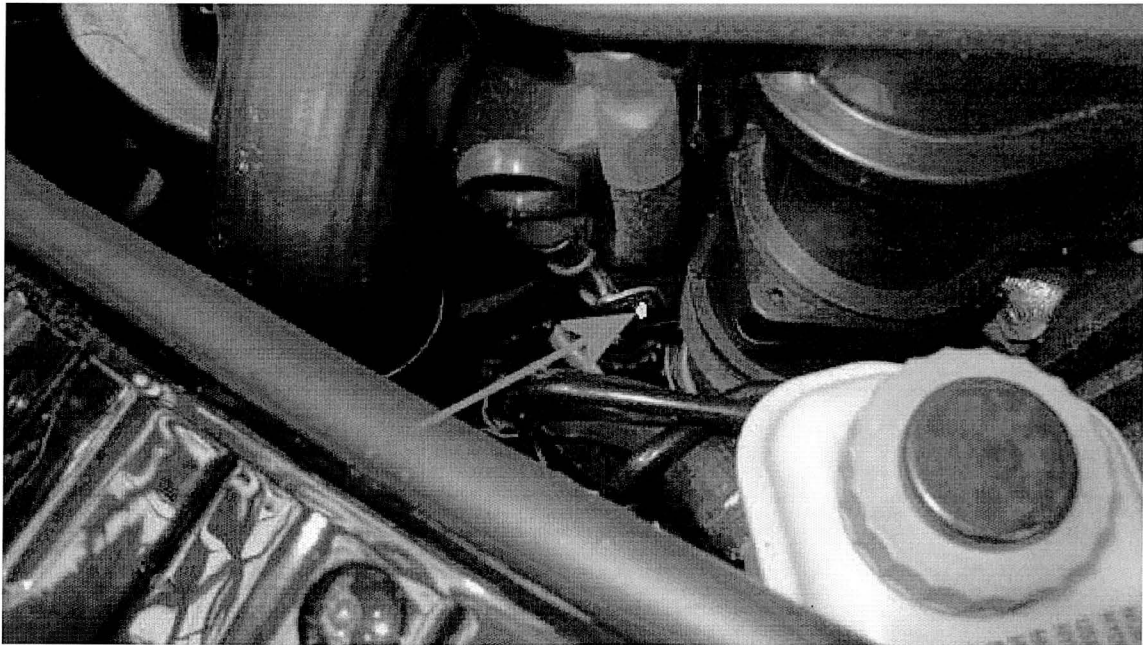
Figure 11

Yellow paint mark on the engine oil dipstick tube bracket (Figure 11)

4. Place a Yellow confirmation mark on the rear of the engine oil dipstick tube bracket (Figure 11)
