NUMBER: 08-048-14 REV. B

DATE: October 30, 2014

Flash: Vehicle Enhancements

2013 - 2014 (FF) 500e

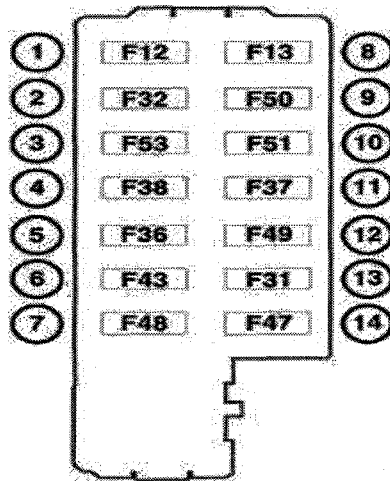
9102135

NOTE: Sometimes when updating the software on these modules, the CTM may stop communicating and/or U11F6-00 is set as an active fault. Pulling the fuse for the CTM will regain communication with that module and change U11F6-00 to a stored DTC.

Fig. 1 Interior fuse panel located by the left kick panel.

15. Is U11F6-00 set as an active fault?
 - a. Yes >>> Proceed to Step #16.
 - b. No >>> Proceed to Step #18.
16. Turn off the ignition and pull fuse F36 for 10 seconds. It is located in the interior fuse panel, which is part of the BCM, see (Fig. 1).

Remove fuse F36 .
