**NUMBER:** 08-048-14 REV. A

Flash: Vehicle Enhancements

**\*\*2013\*\* - 2014 (FF) 500e**

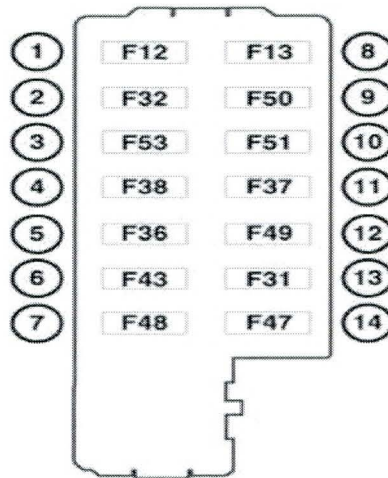
3102133

**Fig. 1 Interior fuse panel located by the left kick panel.**

18. **\*\*Is U11F6-00 set as an active fault?**
  - a. Yes >>> Proceed to Step #19.
  - b. No >>> Proceed to Step #21**\*\*.**
19. Turn off the ignition and pull fuse F36 for 10 seconds. It is located in the interior fuse panel, which is part of the BCM, see (Fig. 1).

Remove fuse F36 .
