**NUMBER:** 08-048-14

Flash: Vehicle Enhancements

2014 (FF) 500e

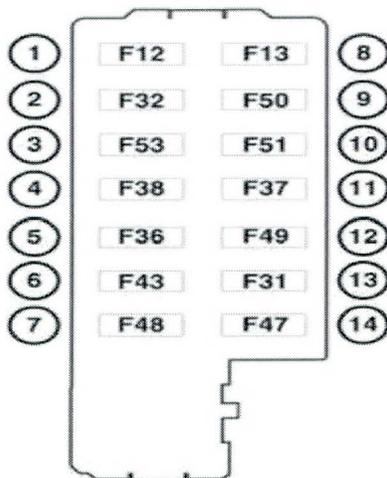
3162133

**NOTE: Sometimes when updating these modules, the CTM may stop communicating and/or U11F6-00 is set as an active fault. Pulling the fuse for the CTM will regain communication with that module and change U11F6-00 to a stored DTC.**

**Fig. 1 Interior fuse panel located by the left kick panel.**

10. Turn off the ignition and pull fuse F36 for 10 seconds. It is located in the interior fuse panel, which is part of the BCM, see (Fig. 1).

Remove fuses F36 and F51.
