**NUMBER:** 08-063-14

GROUP: Electrical

**Incorrect Battery**

Ram 1500 Pickup (Diesel only)

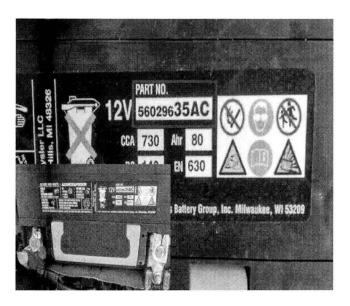
1. Open the hood and inspect if the vehicle has the correct 12 volt battery. H7 (730 Cold Cranking Amps (CCA) battery is the incorrect one. The correct battery will have one of these part numbers, BA00L5850W (Canada only) or BBAH880AA (all other vehicles), see (Fig. 1).

Fig. 1 Location of the part number on the battery

- 2. Does the vehicle have the correct battery?
  - a. Yes >>> This RRT has been completed, Use the inspection LOP (08-08-01-90) to close this RRT.
  - b. No >>> Replace the battery with the correct part, proceed to step Step #3.
- 3. Replace the battery following TechConnect, 08 Electrical/8F Engine Systems/Battery System/BATTERY/Removal and Installation.
