NUMBER: 08-073-14

Alternative Method For Adjusting The Headlamps

2014 (LX) 300

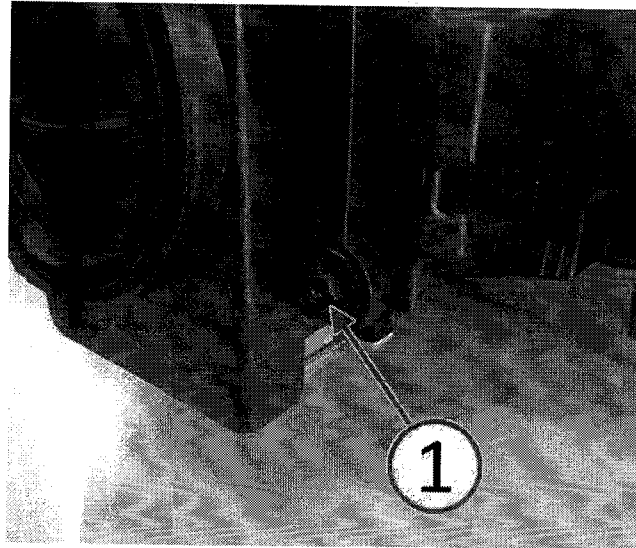
Fig. 1 Headlamp Adjusting Bolt

If the headlamp cannot be adjusted following the standard adjustment procedure (Phillips #2 screwdriver through cone-shaped opening on back of headlamp) due to stripped adjuster bolt teeth, the headlamp must be adjusted by using a deep wall socket or extension to reach the 12 mm hex manufactured into the adjusting bolt on the backside of the headlamp.

- For right side headlamp: Adjust the headlamp using the hex manufactured into the adjusting bolt on the backside of the headlamp (Fig. 1).
- For left side headlamp: Remove the air box. Adjust the the headlamp using the hex manufactured into the adjusting bolt on the backside of the headlamp (Fig. 1). Reinstall the air box.
