NUMBER: 08-079-14

DATE: September 11, 2014

Flash: RA3 RA4 Radio Ignition Off Battery Draw

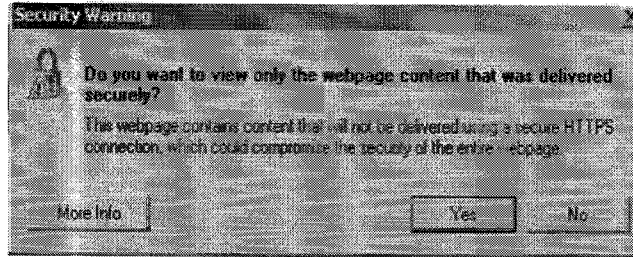
Fig. 1 Pop-up Security Message

2. Go to DealerCONNECT> Service> UCONNECT Information & Utilities> Uconnect Dealer software downloads to download the files.
3. If a security message appears "Do you want to view only the web page content that was delivered securely?" see (Fig. 1). Press **No** to continue.

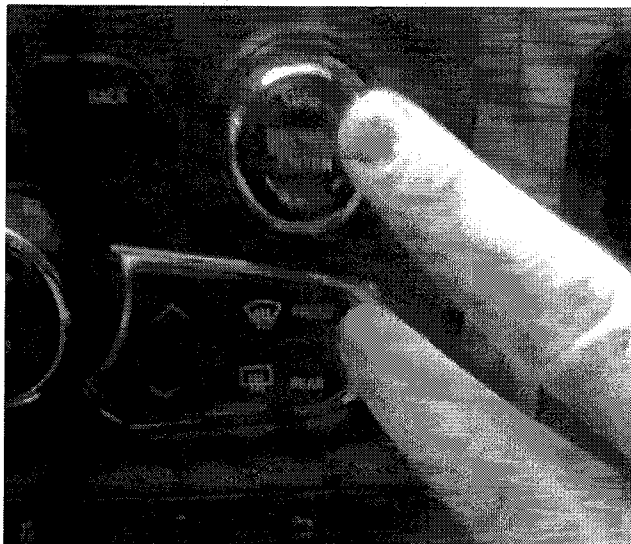
Fig. 2 Take Vehicle Out of Ship Mode

5. Start the vehicle and check if it is still in ship mode. This will be displayed in the Electronic Vehicle Information Center (EVIC).
6. Is the vehicle in Ship Mode?
 - a. Yes >>> Proceed to Step #7.
 - b. No >>> Proceed to Step #8.
7. Press and hold the 'Enter/Browse' button and the 'Front Defrost' (about 5 seconds) until "Ship Mode" is no longer displayed on the instrument cluster, see (Fig. 2).
