NUMBER: 08-084-14

Radio Audio Updates For The Australian Market

NUMBER: 31-002-14

Safety Certification and Tire Pressure Label Replacement Guidelines

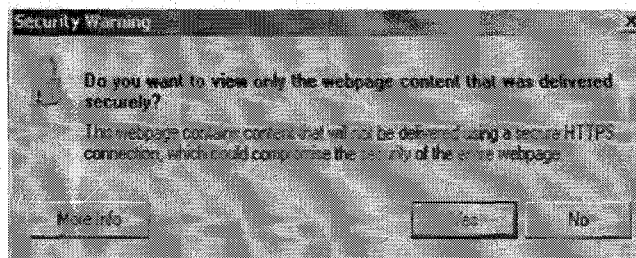
Fig. 1 Pop-up Security Message

1. Has a USB stick been created with the current software update?
 - a. Yes >>> Proceed to Step #5.
 - b. No >>> Proceed to Step #2.
2. Go to DealerCONNECT>Service>UCONNECT Information & Utilities> Uconnect Dealer software downloads to download the latest files.
3. If a security message appears "Do you want to view only the webpage content that was delivered securely?" See (Fig. 1). Press **No** to continue.
