**NUMBER:** 08-085-14 REV. A

Hands Free Feature Inoperative

This bulletin involves updating the Convergence Telematics Module (CTM) software.

2013 - 2014 (PF) Dart

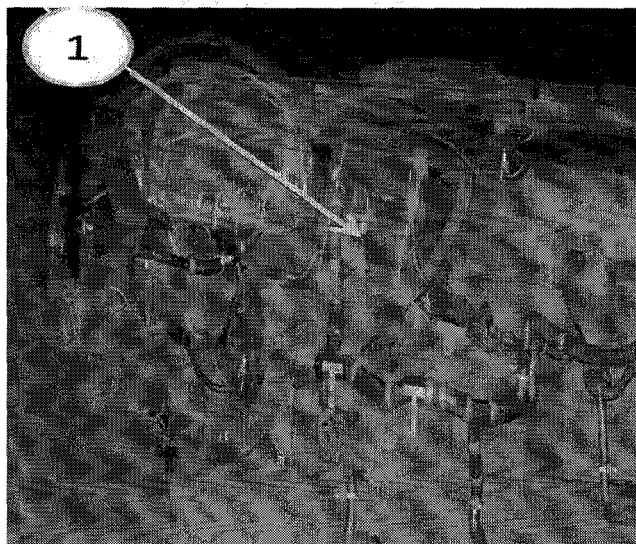
**Fig. 2 CTM Location Under The Dash**

1 - CTM location

19. **\*\*Gain access to the CTM, refer to TechConnect > Electrical/8E - Electronic Control Modules/MODULE, Convergence Telematics/Removal, CTM location see (Fig. 2).\*\***
