**NUMBER:** 08-085-14

Hands Free Feature Inoperative

This bulletin involves updating the Convergence Telematics Module (CTM) software.

2013 - 2014 (PF) Dart

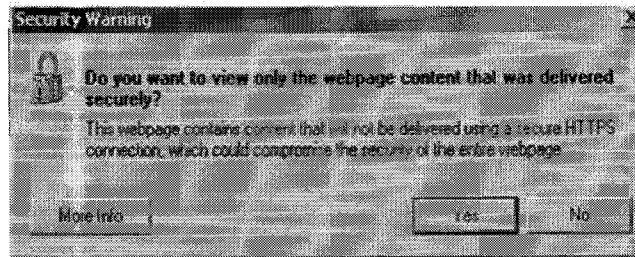
**Fig. 1 Pop-up Security Message**

16. If a security message appears "Do you want to view only the webpage content that was delivered securely?" See (Fig. 1). Press **No** to continue.
