**NUMBER:** 09-001-14

Hard Contact Knocking Noise In Engine Compartment Primarily While Turning Left

2011-2014      JC                                      Journey

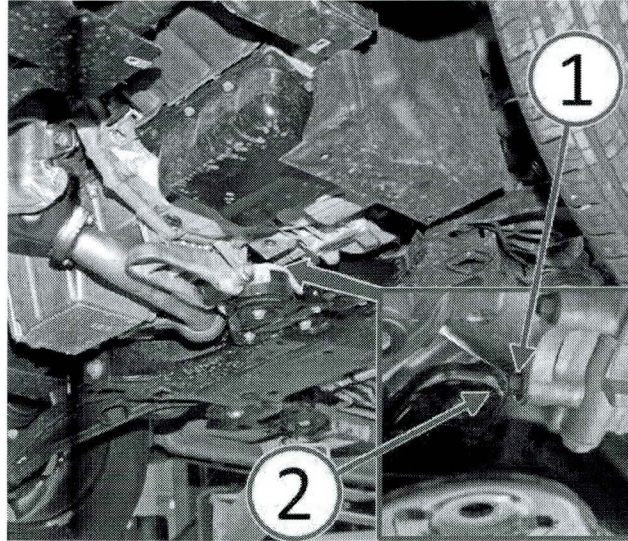
**Fig. 2 Area Of Contact Concern**

Hard contact knocking noise in the engine compartment caused by contact between the Rear Engine Mount Bracket and the fastener on the Power Transfer Unit (PTU). Noise heard primarily while turning left.

3. Inspect for evidence of contact between the Rear Engine Mount Bracket (2) and the fastener (1) on the PTU (Fig. 2). Is evidence of contact observed?
  - a. YES, contact is observed.>>> Continue with Step #4.
  - b. NO, contact is NOT observed.>>> Continue with further diagnosis. This bulletin does not apply.

- 
4. Replace the Rear Engine Mount Bracket. Refer to the detailed repair procedures available in: DealerCONNECT> TechCONNECT under: Service Info> 09 - Engine, 2.0L Diesel> Engine Mounting> BRACKET, Engine Mount, Rear Mount> Removal/Installation.

**NOTE: The exhaust crossunder pipe gasket must be replaced as part of the Rear Engine Mount Bracket replacement procedure.**
