**NUMBER:** 17-003-14  
**GROUP:** Rear Suspension  
**DATE:** August 15, 2014

**SUBJECT:**  
Rear End Creak Noise While Going Over Bumps

**MODELS:**  
2014 (JS) 200 (Convertible Only)

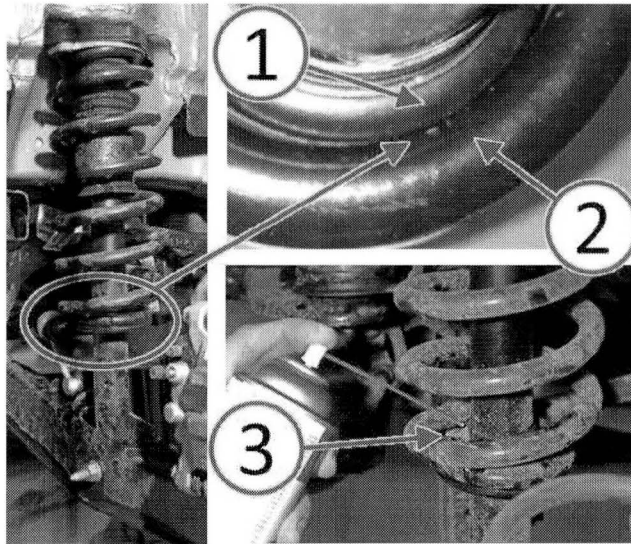
**Fig. 1 Noise Diagnosis**

**SYMPTOM/CONDITION:**  
Squeak or creak noise coming from the rear of the vehicle, while going over bumps at low speeds between 5 - 20 MPH.

- REPAIR PROCEDURE:**
1. Inspect the lower spring seat isolator for the source of squeak or creak noise caused by contact between the suspension spring (2) and the spring seat isolator (1) as shown in (Fig. 1).
  2. For diagnostic purposes, jounce the vehicle to produce the squeak or creak noise and test if the noise can be temporarily silenced by the application of silicone spray lube to the lower spring isolator (3) (Fig. 1).

- 1 - Spring Seat Isolator
- 2 - Rear Suspension Spring
- 3 - Silicone Spray Application

6. Remove the left and right rear shock absorbers. Refer to the detailed procedures available in DealerCONNECT> TechCONNECT under: Service Info> 17 - Rear Suspension> SHOCK ABSORBER, Suspension, Coil-Over> Removal.
7. Replace both the left and right rear springs. Refer to the detailed procedures available in DealerCONNECT> TechCONNECT under: Service Info> 17 - Rear Suspension> SHOCK ABSORBER, Suspension, Coil-Over> Disassembly/Assembly.
8. Install the left and right rear shock absorbers. Refer to the detailed procedures available in DealerCONNECT> TechCONNECT under: Service Info> 17 - Rear Suspension> SHOCK ABSORBER, Suspension, Coil-Over> Installation.
