NUMBER: 17-004-14
GROUP: Rear Suspension
DATE: August 16, 2014

Right Rear Spring Shifted In Upper Isolator And Possible Clunk Noise

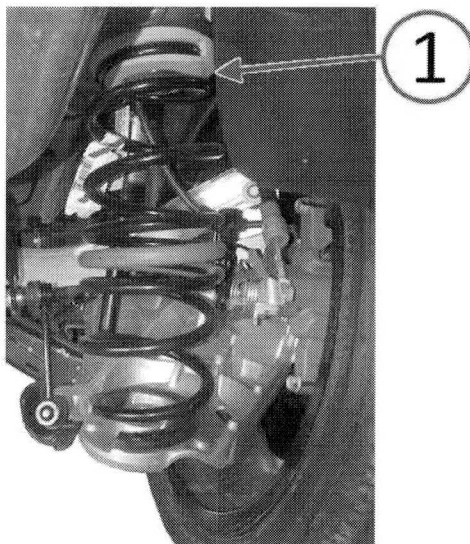
Fig. 1 Spring Seat Upper Isolator

1. Inspect the positioning of the right side rear suspension spring in the upper spring seat isolator (Fig. 1).

1 - Upper Spring Seat Isolator

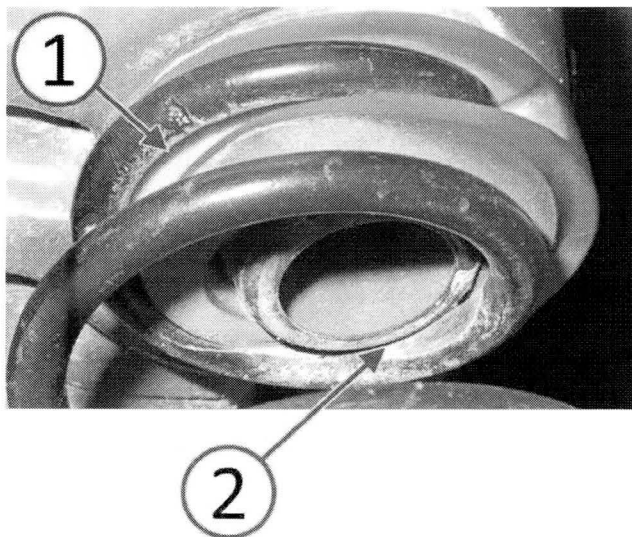
Fig. 2 Spring Shifted In Upper Isolator

Right side rear suspension spring is shifted in the upper spring mount isolator and possibly a clunk noise can be heard or felt coming from the rear of the vehicle, while going over bumps.

2. Is the right side rear spring shifted in the upper spring seat isolator (1) and/or possibly touching the upper spring seat (2) as shown in (Fig. 2)?
- Yes>>> Proceed to Step #3.
 - No>>> Continue further diagnosis, this bulletin does not apply.

1 - Spring Shifted Position In Isolator

2 - Spring Touching Spring Seat

- 3. Replace both the left and right rear springs. Refer to the detailed procedures available in DealerCONNECT> TechCONNECT under: Service Info> 17 - Rear Suspension> SPRING(S)> Removal/Installation.
