NUMBER: 18-028-14 REV. B

GROUP: Vehicle Performance

Flash: MIL Illumination - Diagnostic and System Improvements

2014 (DS) Ram Pickup (1500)

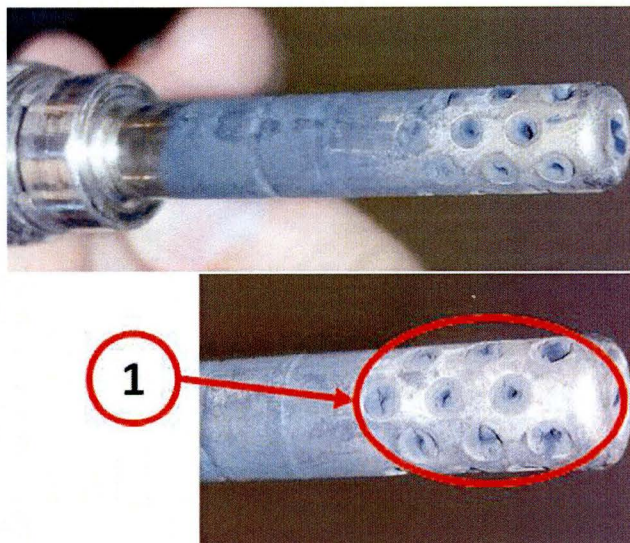
Fig. 1 EGT Sensor Bank 1 Sensor 2

10. ****Inspect the sensor body and probe for any signs of damage or excessive soot.****
Refer to (Fig. 1).

1 - Excessive soot blocking sensor ports.

-
11. Was excessive soot found on the sensor?
 a. Yes>>> Proceed to [Step #12](#).
 b. No>>> Proceed to [Step #13](#).
12. ****Using shop air set to a maximum of 80 psi, clean all excessive soot from the sensor probe.****

13. **** Using a suitable multi-meter with appropriate test probes, test the resistance between the sensor connector terminals 1 and 2. With the sensor at room temperature, 65-75 °F (18-25 °C), the resistance should measure between 200 and 240 ohms.****
