NUMBER: 18-028-14 REV. C

Flash: MIL Illumination - Diagnostic and System Improvements

2014 (DS) Ram Pickup (1500)

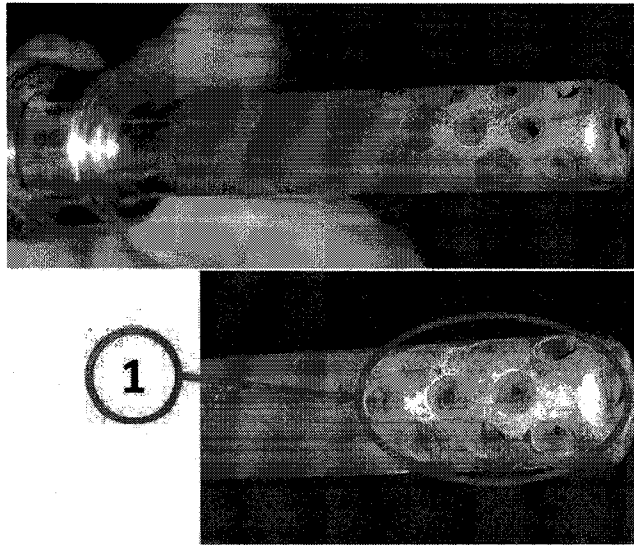
Fig. 1 EGT Sensor Bank 1 Sensor 2

10. Inspect the sensor body and probe for any signs of damage or excessive soot. Refer to (Fig. 1).

1 - Excessive soot blocking sensor ports.

-
11. Was excessive soot found on the sensor?
- Yes>>> Proceed to Step #12.
 - No>>> Proceed to Step #13.
12. Using shop air set to a maximum of 80 psi, clean all excessive soot from the sensor probe.
