NUMBER: 18-028-14 REV. D

GROUP: Vehicle Performance

Flash: MIL Illumination - Diagnostic and System Improvements

2014 (DS) Ram Pickup (1500)

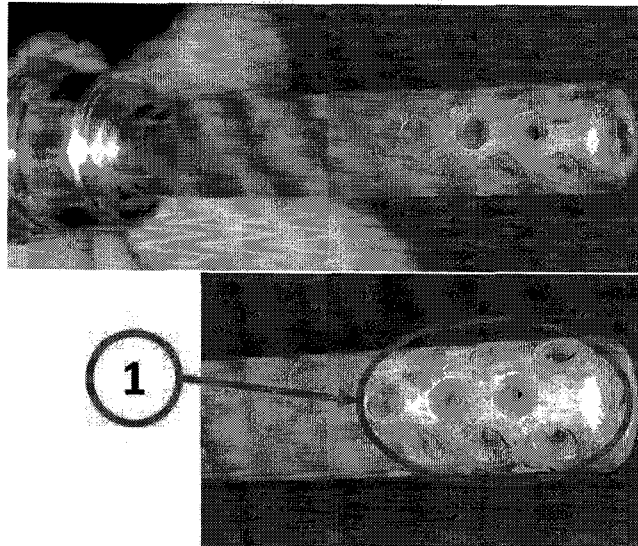
Fig. 1 EGT Sensor Bank 1 Sensor 2

10. Replace the O2 sensor. Refer to detailed repair procedures available in DealerCONNECT> TechCONNECT> Service Info Section 14 - Fuel System> Fuel Injection, Diesel> Sensor, Oxygen> Removal/Installation. Proceed to Step #11.
11. Remove the EGT Sensor 1/2 located in the inlet of the Diesel Particulate Filter (DPF)/Diesel Oxidation Catalyst (DOC) assembly. Refer to detailed removal procedures available in DealerCONNECT> TechCONNECT> Service Info Section 11 - Exhaust System> Sensor, Exhaust Temperature> Removal> Exhaust Gas Temperature Sensor 1/2.
12. Inspect the sensor body and probe for any signs of damage or excessive soot. Refer to (Fig. 1).

1 - Excessive soot blocking sensor ports.

-
13. Was excessive soot found on the sensor?
 - a. Yes>>> Proceed to Step #14.
 - b. No>>> Proceed to Step #15.
 14. Using shop air set to a maximum of 80 psi, clean all excessive soot from the sensor probe.

15. Using a suitable multi-meter with appropriate test probes, test the resistance between the sensor connector terminals 1 and 2. With the sensor at room temperature, 65-75 °F (18-25 °C), the resistance should measure between 200 and 240 ohms.
