NUMBER: 18-054-14

Intermittent Extended Crank, Long Crank Time.

This bulletin involves inspecting the Bank 1 Camshaft Position Sensor serial number and if necessary, replacing the sensor.

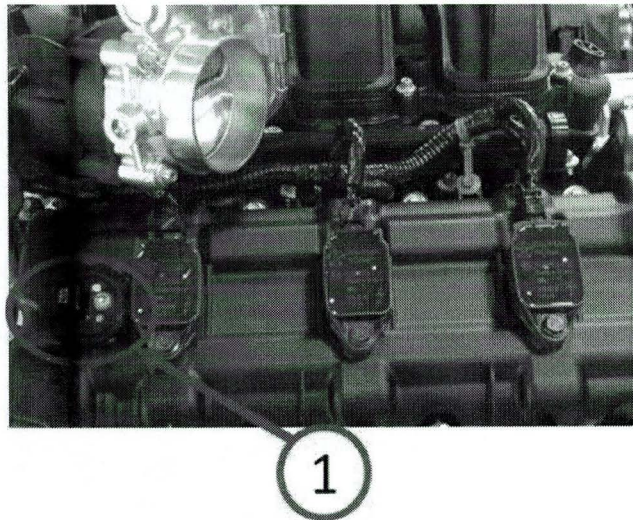
Fig. 1 Camshaft Position Sensor Location

1. Open the hood and remove the engine cover.
2. Locate the Bank 1 Camshaft Position Sensor located in the top rear of the valve cover. See (Fig. 1).

1 - Camshaft Position Sensor

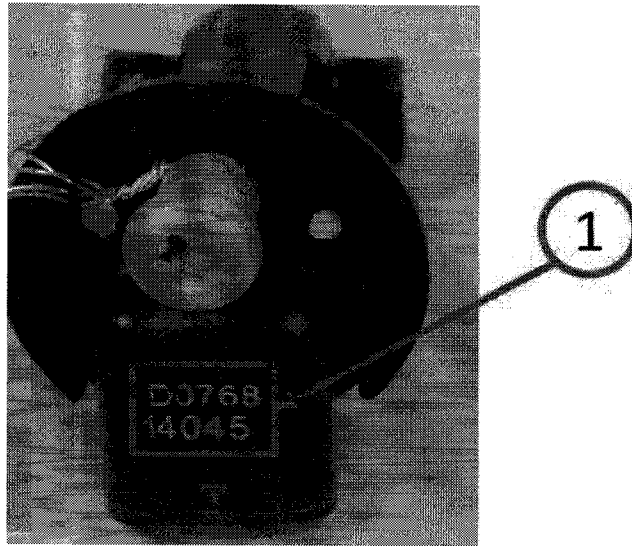
Fig. 2 Camshaft Position Sensor

3. Inspect and record the serial number stamped on the top of the sensor. See (Fig. 2).

1 - Camshaft Position Sensor Serial Number

4. Does the serial number begin with the letter "D"?
 - a. Yes>>> Replace the camshaft position sensor per published service procedures in Tech Connect Service Information Section 08 - Electrical>8I - Ignition Control>Sensor, Camshaft Position>Removal/Installation, and proceed to .
 - b. No>>> This bulletin does not apply. Further diagnostics are required.
5. Using WiTECH perform the Cam/Crank Variation Relearn procedure and follow the on screen instructions.
6. The bulletin is now complete.
