NUMBER: 21-037-14

DATE: November 12, 2014

66RFE Transmission Slip Under High Engine Load And Premature Wear

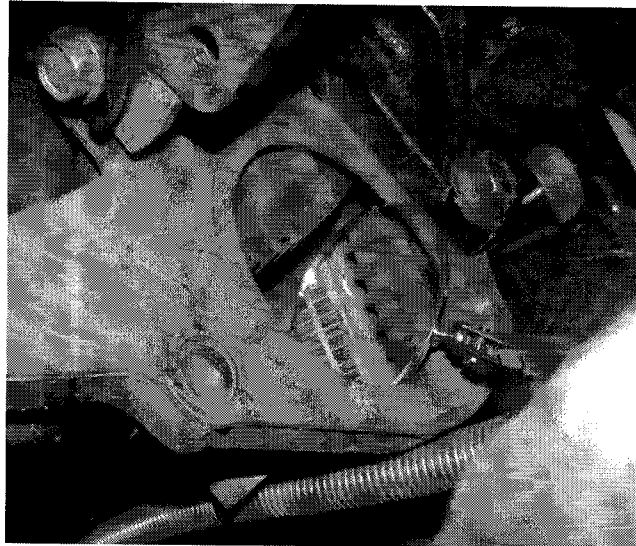
Fig. 2 Torque Converter Label Inspection

NOTE: Only the first 7 digits on the bar code serial number will be used to determine replacement. If the bar code is missing then the torque converter is to be considered suspect and should be replaced.

1. Disconnect and isolate the negative battery cable.
2. Raise and support the vehicle on a suitable hoist. Refer to the detailed service procedures in DealerCONNECT/techCONNECT Service Info section 04 - Vehicle Quick Reference> Hoisting> Standard Procedure.
3. Remove the starter to gain access to the inside of the bell housing. Refer to detailed service procedures in DealerCONNECT/techCONNECT Service Info section 08 - Electrical> 8F - Engine Systems> Starting> Starter> Removal/Installation.
4. Using a suitable socket and ratchet, rotate the engine clockwise until the bar code label on the torque converter is visible via inspection mirror. If necessary, mark the torque converter using an appropriate marker to ensure full engine rotation has been achieved. Refer to (Fig. 1) and (Fig. 2).

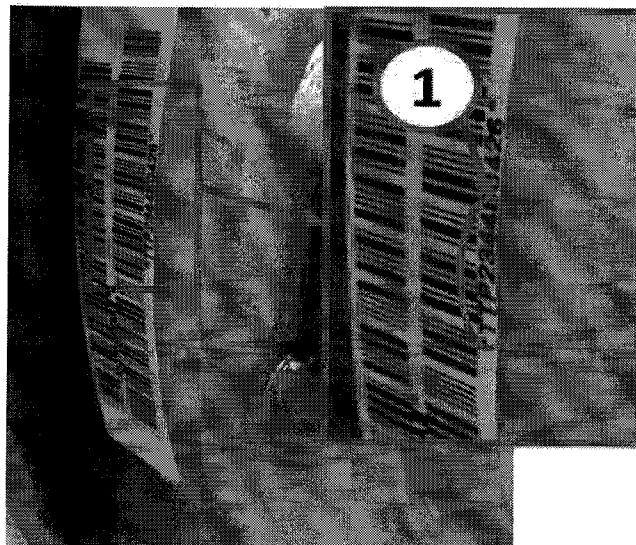
Fig. 3 Torque Converter Label

5. Record the serial number beginning with TTP. See (Fig. 3).

1 - Torque Converter Build Date

6. Does the torque converter serial number fall between TTP2544xxxxx and TTP2734xxxxx?
- Yes>>> Replace the torque converter. Refer to detailed service procedures in DealerCONNECT/techCONNECT Service Info section 21- Transmission and Transfer Case> Automatic - 66RFE> TORQUE CONVERTER> Removal/Installation.
 - No>>> No further repairs are necessary. Use LOP 21-00-22-90 to close out the RRT portion of this service bulletin.
