**NUMBER:** 23-006-14

Left Rear Outer Door Belt Molding Cut Incorrectly At Division Bar

2014 LX 300

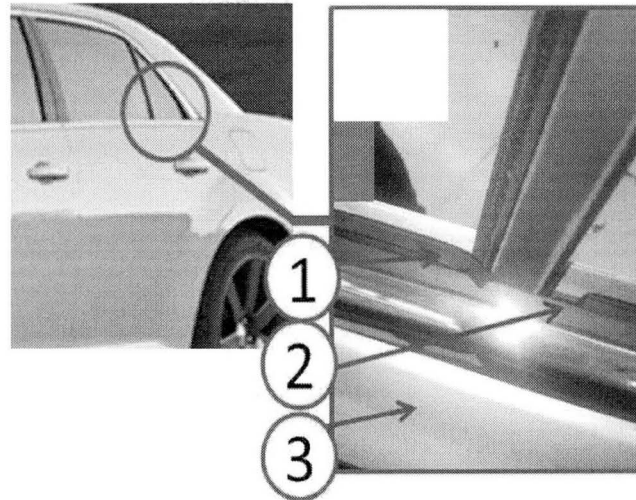
**Left Rear Door**

1. Inspect the left rear outer door belt molding, was the seal cut incorrectly as shown in (Fig.1)?
  - a. Yes>>> Proceed to Step 2.
  - b. No>>> Return the vehicle to the customer or dealer inventory.

- 1 - Left Outer Door Belt Molding Seal And Cut Area
- 2 - Left Outer Door Belt Molding
- 3 - Left Rear Door

2. Remove and replace the left rear outer door belt molding. Refer to the detailed repair procedures available in: DealerConnect> TechCONNECT under: Service Info> 23 - Body> Door - Rear> Molding, Door Belt, Outer> Removal/Installation.
