**NUMBER:** 23-009-14 REV. A

Gap At Rear Spoiler To Decklid

This bulletin involves inspecting and if necessary replacing the rear deck lid spoiler.

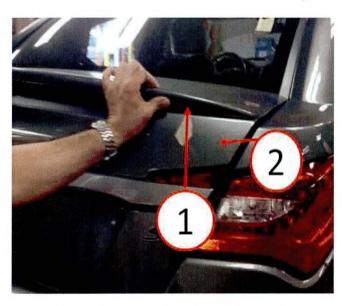
Fig. 1 Spoiler Inspection 1

- 1. Apply vertical upward finger load on rear most edge of spoiler at the body cross car centerline and 4" from outboard ends (Fig. 1)(Fig. 2). Inspect rear edge of spoiler for tape adhesion, was the adhesive separated and/or separating (Fig. 3)?
  - a. Yes>>> Proceed to Step 2.
  - b. No>>> Return the vehicle the customer or dealer inventory.

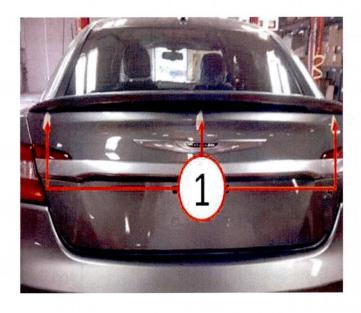
Fig. 2 Spoiler Inspection 2

1 - Areas to apply vertical upward finger load

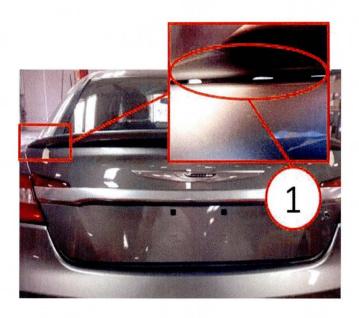
Fig. 3 Adhesion Inspection

1 - Adhesion failure

2. Remove and replace the deck lid spoiler. Refer to the detailed repair procedures available in: DealerConnect> TechCONNECT under: Service Info> 23 -Body> Exterior> Spoiler> Removal/Installation.

NOTE: Clean the surface area where the two sided tape will bond to the deck lid with isopropyl alcohol prior to installing the replacement spoiler.
