NUMBER: 23-010-14

Click, Creak, Or Groaning Sound Near C-Pillar, Dual Pane Sunroof (Sales Code GWJ)

This bulletin involves inspecting and if necessary replacing rear sunroof glass panel or adding structural adhesive at the right rear corner C-Pillar sunroof opening reinforcement.

2013 - 2014 WK Grand Cherokee

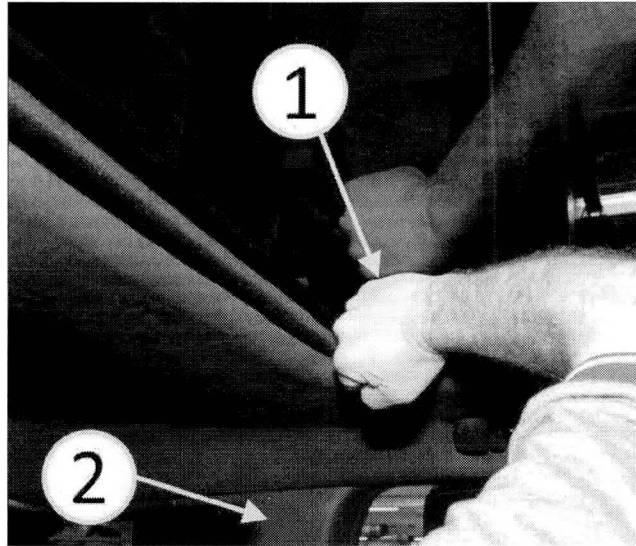
Fig. 1 Push And Tap On Sunroof Glass Panel

- 1 - Push/Tap On Glass
2 - C-Pillar
-

1. Test drive the vehicle over uneven road surfaces or where the customer advises the noise can be duplicated. Attempt to duplicate the noise by pushing upward on the dual pane sunroof rear panel at the rear corner with increasing pressure then release while listening for a creak/groan noise. Also try tapping with fist on the dual pane sunroof rear panel at the rear corner while listening for a click/tick noise (Fig. 1). If the suspect noise is duplicated, proceed to Step #2 .

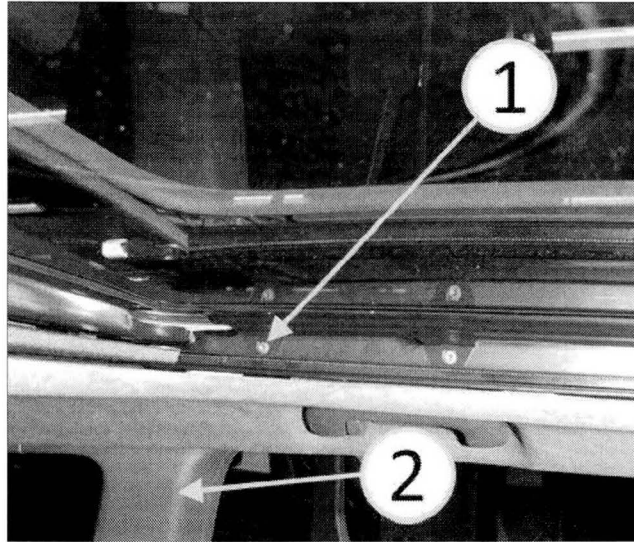
Fig. 2 Sunroof Glass Panel Screw

- 1 - Screw
- 2 - C-Pillar

3. Remove the rear sunroof pane rear attaching screw on the side where the noise is heard (Fig. 2).

-
4. Repeat the test by tapping with a fist on the dual pane sunroof rear panel at the rear corner while listening for the click/tick noise as was done in Step #1 to verify if removing the screw turns off the sound. Was the click/tick sound eliminated?
 - a. Yes>>> Proceed to Step #5.
 - b. No>>> This bulletin does not apply, continue with further diagnosis.
 5. Replace the rear sunroof panel. Refer to the detailed repair procedures available in: DealerCONNECT> TechCONNECT under: Service Info> 23- Body> Sunroof, Dual Pane> GLASS, Sunroof, Rear> Removal/Installation.
 6. Confirm the issue has been resolved then, return the vehicle to the customer.

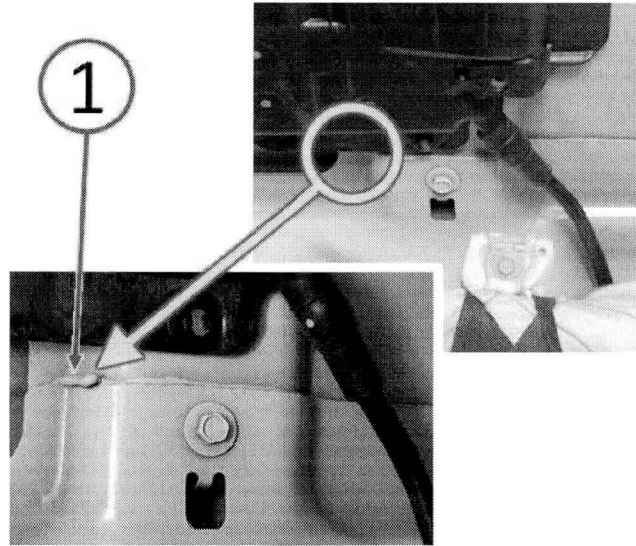
Fig. 3 Visually Inspect For Adhesive

8. Visually inspect for adhesive filling the space between the sheet metal structural components at C-pillar nearest rear corner of sunroof module where the noise was heard. Can adhesive be seen filling the space identified in (Fig. 3)?

1 - Adhesive

- a. Yes>>> Repeat the diagnostic test of pushing upward on the dual pane sunroof rear panel at the rear corner with increasing pressure then release while listening for creak/groan noise as was done in Step #1 to ensure that the noise is actually coming from the area identified in (Fig. 3) before proceeding to Step #9. If noise is not coming from this structural joint, than this bulletin does not apply and further diagnosis is required.

- b. No>>> Adhesive was not observed filling the identified area. Continue to Step #9.

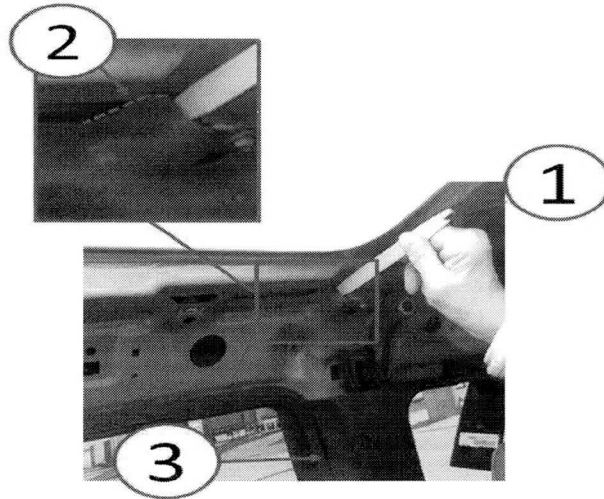
Fig. 4 Dual Pane Sunroof Reinforcement

- 1 - Trim Stick
- 2 - Sheet Metal Flange
- 3 - C-Pillar

-
9. Remove the dual pane sunroof module for access to the sheet metal flange. Refer to the detailed repair procedures available in: DealerConnect> TechCONNECT under: Service Info> 23 - Body> Sunroof, Dual Pane> Removal
 10. Insert trim stick C-4755 (1) at the location shown in (Fig. 4). Can the metal be easily moved by moving the trim stick left to right?
 - a. Yes>>> Proceed to Step #11.
 - b. No>>> This bulletin does not apply, continue with further diagnosis.
 11. Clean and prepare the sheet metal flange (2) identified in (Fig. 4) for application of structural adhesive per the adhesive manufacturer's recommendations.
 12. Apply Lord Fusor 112B structural adhesive or equivalent at the sheet metal flange, location (2) identified by the dashed line in (Fig. 4).

-
13. Allow the adhesive to cure per the adhesive manufacturer's recommendations.
 14. Install the dual pane sunroof module. Refer to the detailed repair procedures available in: DealerConnect> TechCONNECT under: Service Info> 23 - Body> Sunroof, Dual Pane> Installation.
 15. Install the headliner. Refer to the detailed procedures available in DealerCONNECT> TechCONNECT>: Service Info> 23 -Body> Interior > Headliner> Installation.
 16. Confirm the issue has been resolved, then return the vehicle to the customer.
