NUMBER: 23-013-14

Incorrect Color Door Trim Panels And/Or Overhead Console

Caravan / Town & Country

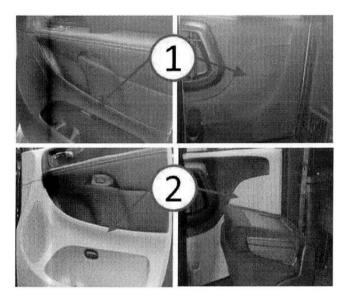
Fig. 1 Door Panel Color Verification

- 1 All Black CORRECT
- 2 Two-Tone REPLACE
- 2. Inspect the color of the second row overhead console.
 - a. Second row overhead console one color all black (1) (Fig. 2). CORRECT, this bulletin does not apply.

- NOTE: Vehicle may be equipped with two-tone second row overhead console and all black door panels or two-tone second row overhead console and two-tone door panels.
- 1. Inspect the color of the door panels.
 - a. Door panels one color all black (1) (Fig. 1). CORRECT, proceed to Step #2.
 - b. Door panels two-tone gray/black (2) (Fig. 1). REPLACE the front door and sliding door trim panels. Refer to the detailed repair procedures available in: DealerConnect> TechCONNECT under: Service Info> 23 - Body> Door - Front> PANEL, Door Trim> Removal/Installation and 23 - Body> Doors - Sliding> PANEL, Door Trim> Removal/Installation.

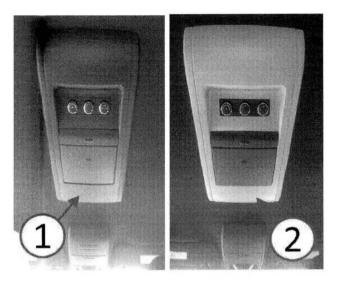
Fig. 2 Overhead Console Color Verification

- 1 All Black CORRECT
- 2 Two-Tone REPLACE

b. Second row overhead console - two-tone gray/black (2) (Fig. 2). REPLACE the second row overhead console. Refer to the detailed repair procedures available in: DealerConnect> TechCONNECT under: Service Info> 23 - Body> Interior> CONSOLE, Overhead, Rear> Removal/Installation> SHORT OVERHEAD CONSOLE - NON SUNROOF EQUIPPED
