NUMBER: 23-016-14

Rattle Noise From The Right Rear Sliding Door While Driving Over Bumps

2013 - 2014 RT

Town And Country / Caravan

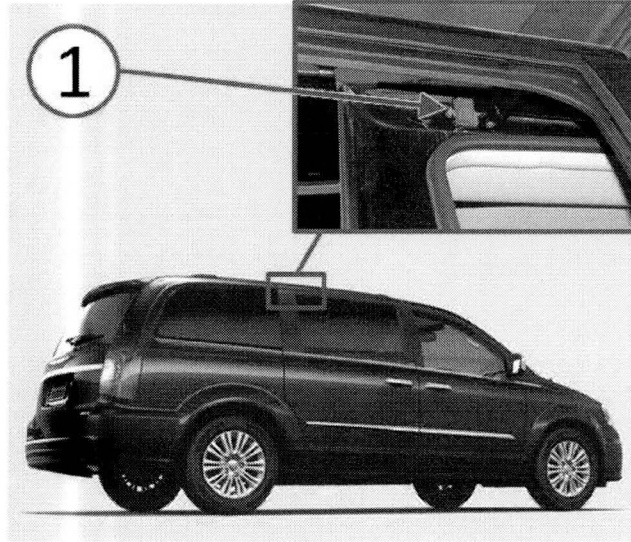
Fig. 1 Remove Bumper

1 - Rubber Bumper

1. Test drive the vehicle over bumps to verify that the rattle noise is coming from the right rear sliding door.
2. Pause the test drive stopping the vehicle at a safe location such as a parking lot.
3. Open the right rear sliding door and remove the rubber bumper (Fig. 1) from the rear end of the upper door track, then close the door.

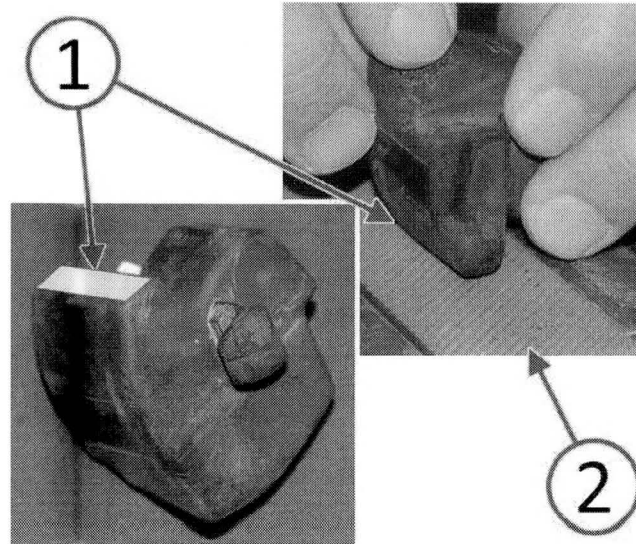
Fig. 2 Modify Bumper

- 1 - Rubber Bumper Surface
- 2 - Coarse File

-
4. Continue test driving the vehicle over the same road conditions to determine if removal of the rubber bumper eliminated the rattle noise.
 - a. YES the rattle noise was eliminated. >>> Continue to Step #5.
 - b. NO the rattle noise was NOT eliminated. >>> Reinstall the rubber bumper. This Bulletin does not apply. Further diagnosis is required.
 5. Using a coarse file (2), remove 1 mm of material from the rubber bumper surface (1) indicated in (Fig. 2).

6. Install the modified rubber bumper to the vehicle.

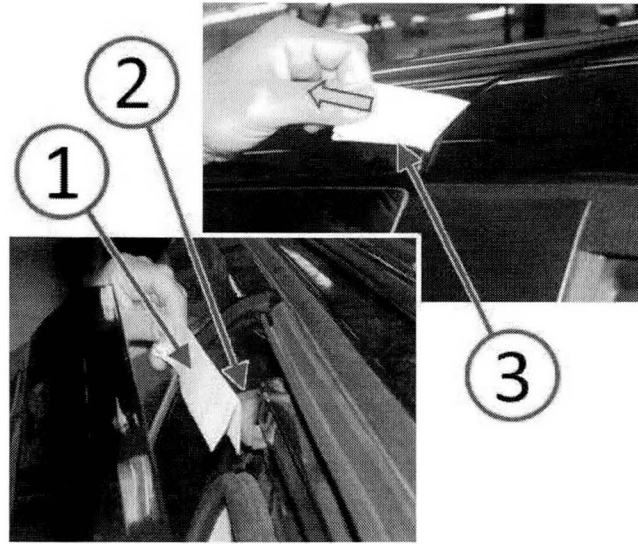
Fig. 3 Check Bumper Clearance

NOTE: There is an intended design clearance of approximately 1.8 mm between the rubber bumper and the sliding door inner panel.

- 1 - Position Paper
- 2 - Rubber Bumper
- 3 - Tension/Resistance Test

7. Hold a piece of paper (1) in front of the rubber bumper (2). Make sure fingers and hands are clear of the door opening then shut the door while holding the paper in position (Fig. 3).

8. Slowly pull the paper (3) while feeling for any tension or resistance on the paper during paper removal (Fig. 3). If tension or resistance was felt while removing the slip of paper, that would indicate a contact interference condition between the rubber bumper and the door inner panel.
- a. YES, tension or resistance was felt. >>> Repeat the rubber bumper material removal Step #5 and retest clearance with the slip of paper until no tension or resistance is felt.
 - b. NO, tension or resistance was NOT felt. >>> Continue to Step #9.
