NUMBER: 23-018-14

Armrest Storage Compartment Lid Difficult To Latch

This bulletin involves replacing the front center seat armrest storage compartment lid bumpers.

2013-2014	DS	1500 Pickup
2013-2014	DJ	2500 Pickup
2013-2014	DP	4500/5500 Cab Chassis

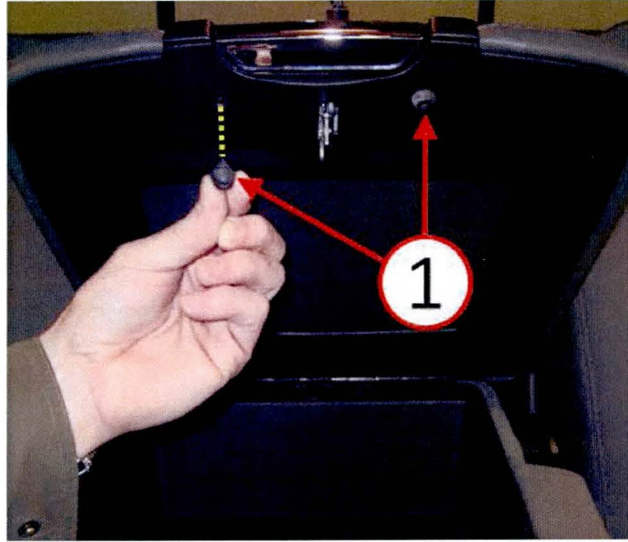
Fig. 1 Armrest Lid Bumper Replacement

Front center seat armrest storage compartment lid is difficult to latch due to hard lid bumpers.

1. Replace both front center seat armrest storage compartment lid bumpers (Fig. 1).
