**NUMBER:** 23-019-14

Electronic Back Light Grid May Short Out To Carbon Fiber Inner Panel

2013 (ZD) Viper

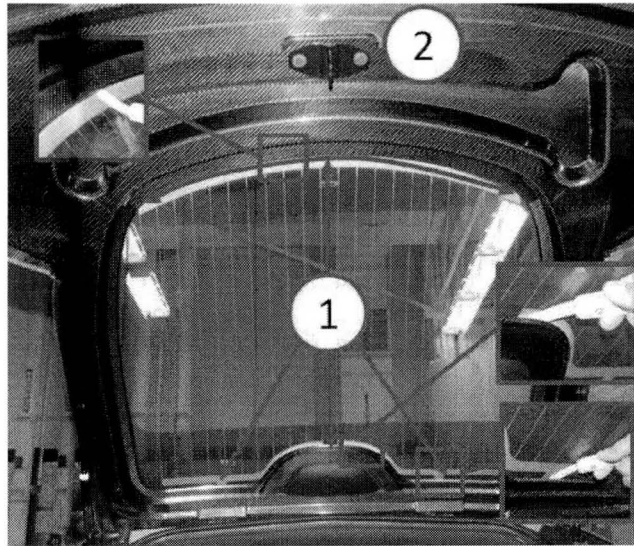
**Fig. 1 Gap Inspection**

1. Inspect the gap between the liftgate glass silver band and the liftgate around the top and bottom of the liftgate assembly as shown in (Fig. 1).

- 1 - Inspect between liftgate inner and back glass  
2 - Liftgate inner

- 
2. Is the clearance between the glass silver band and the liftgate flange between .25mm and 1.5mm?
    - a. Yes>>> Clean the liftgate edge with isopropyl alcohol. Cut Mopar p/n 05019054AA anti-squeak tape in 1/4"(6.35mm) pieces and apply one piece at the top left and right side of the liftgate edge (Fig. 2). The tape is to wrap around the edge of the liftgate panel, providing a barrier to it and the glass.
    - b. No>>> Proceed to Step #4.

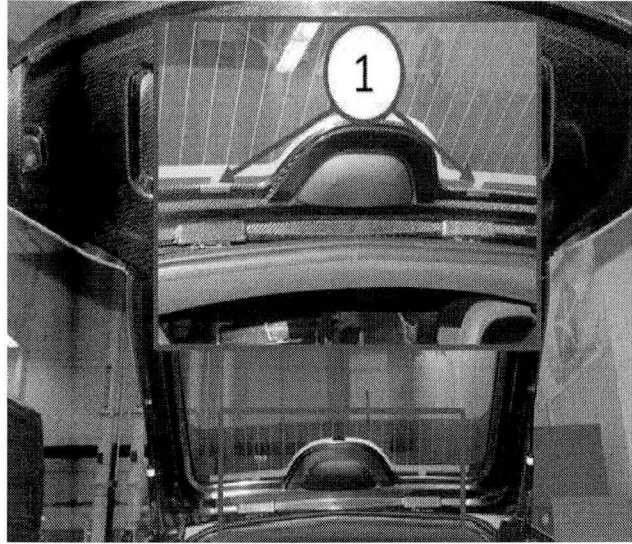
**Fig. 2 Anti-Squeak Tape Installation**

1 - Anti-squeak tape installation areas
