| <b>Topic</b> | Front seat belt webbing stitch cover scuffs seat cushion valance |
| <b>Transaction No.</b> | 2036819/1 |

### New Continental GT Convertible

Front seat belt webbing stitch cover scuffs seat cushion valance

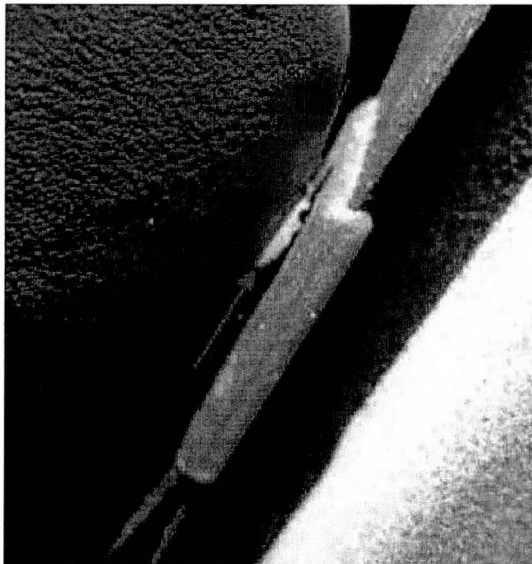
Figure 1

The seat belt webbing incorporates a plastic cover isolating the stitching at the anchor loop. This plastic cover is etched with legislative data relevant to the restraint system, the border surrounding the etched data can contain plastic burrs forming an abrasive surface. Certain seat positions bring the abrasive surface on the plastic cover into contact with the seat valance and cause the leather trim on the valance to be scuffed (see Figure 1, 1a, 1b and 1c)
