Topic	Flying Spur - Potential mismatch - Keys to entry and start authorisation control unit control J518 (SC14/12)
Market area	Worldwide Bentley (1WBE)
Brand	Bentley
Transaction No.	2037366/1
Campaign number	EA12
Note	
Type	
US code

EA12

Transaction No.: 2037366/1

Flying Spur - Potential mismatch - Keys to entry and start authorisation control unit control J518 (SC14/12)

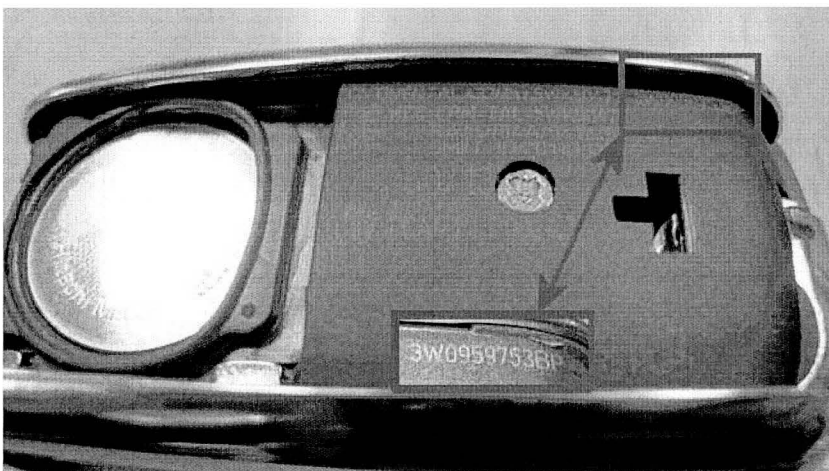
2. With the key fob back removed check the part number of the key, the part number is located as shown in Figure 1

The part number is formatted as 3W0 959 753XX

The suffix (XX) identifies the generation of the key as follows:

Generation type	Suffix (XX)
1	AB - AD - AF - AH - AK - AM - AP - AR - AT - BB - BD - BF - BG - BH - BJ - BK - BL - BM - BN

- T
2	BP - BQ - BR - BS - BT - CA

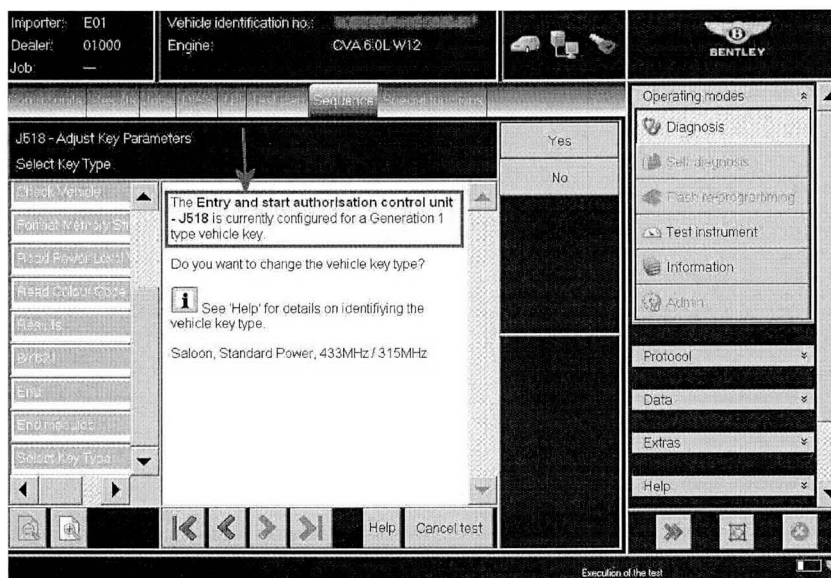
- Figure 6 confirms the Generation of the Entry and start authorisation control unit -J518 -

IMPORTANT: Should the Generation of the key match the entry and start authorisation control unit -J518- no further action is required, should a mismatch be evident please go to Section 2 to change the Generation configuration within control unit -J518-
