TECHNICAL BULLETIN
J034NAS2
11 APR 2014

Safety Recall: Engine Charge Air Cooler Hose Detachment

XF (X250)

Model Year:	2013-2014	Engine:	GTDi 2.0L Petrol
VIN:	S55275-U10625

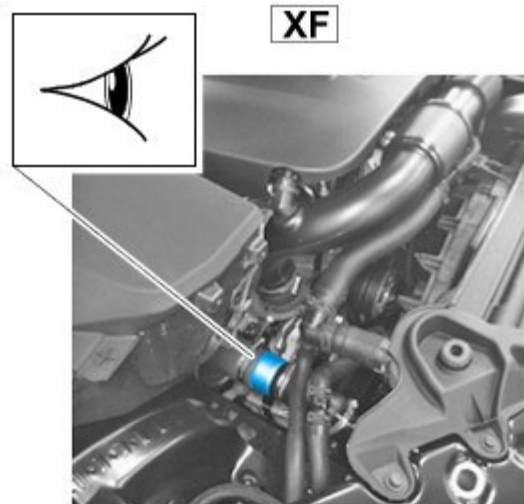
E159753

1. Open hood.
2. Locate the Charge Air Cooler (CAC) hose to the resonator connection.

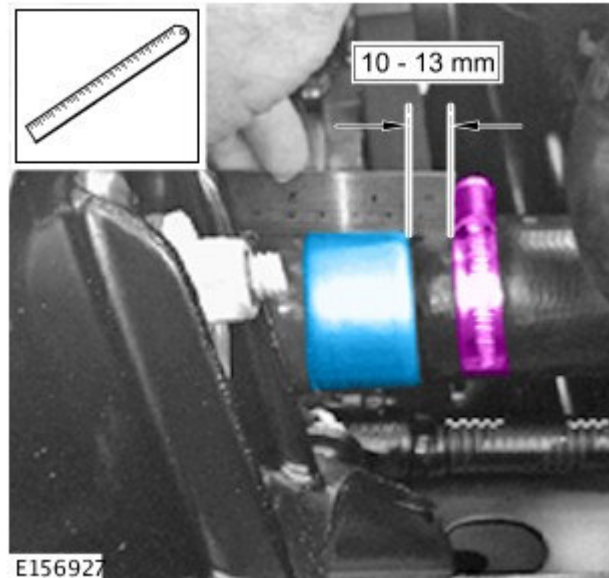
3. Check position of the charge air cooler hose clip.

- If: the clip is less than 10mm from the resonator; a gap exists between the resonator and the end of the hose; or the clip is not positioned squarely on the hose, carry on from step 4.
- If: the clip is between 10mm and 13mm from the edge of the resonator; and the hose is butted against the resonator, carry on from step 5.

4. Reposition hose correctly on the resonator and position the clip 13mm from the edge of the resonator.

5. Tighten the clip to 6Nm, ensuring the clip remains in position and square to the edge of the resonator.
