TECHNICAL BULLETIN
J036NAS1
13 JUN 2014

Safety Recall: Rear Brake Pipe Wear

XF (X250)
Model Year: 2013-2014
VIN: S65176-U29377

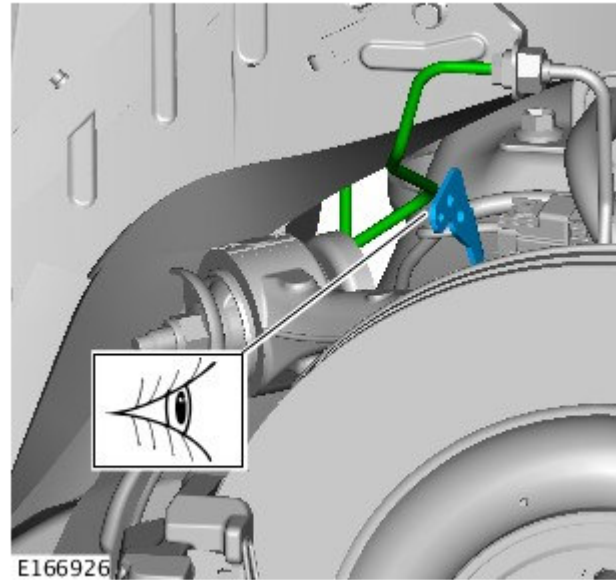
1. Remove the rear wheels and tires (see TOPIx Workshop Manual, section: 204-04).
2. Check to see if there is any damage to the brake pipe, in the area where it can come into contact with the redundant bracket.

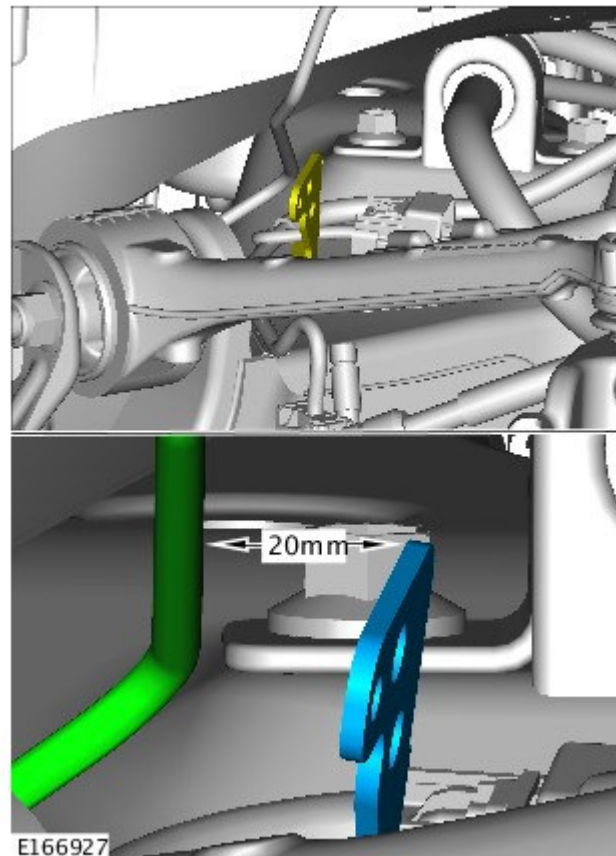
3. Check to see if there is a 20mm gap between the redundant bracket and the brake pipe.

- If required, use a suitable tool to reposition the redundant bracket on the rear subframe so there is a 20mm gap between the bracket and the brake pipe.
