TECHNICAL BULLETIN
JTB00278NAS2
31 MAR 2014

SECTION: 303-03

Coolant Pump Diagnostics

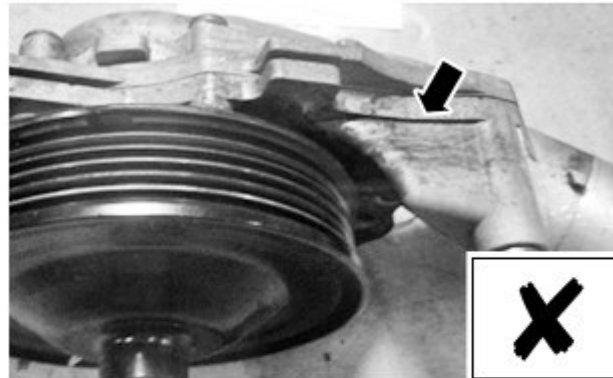
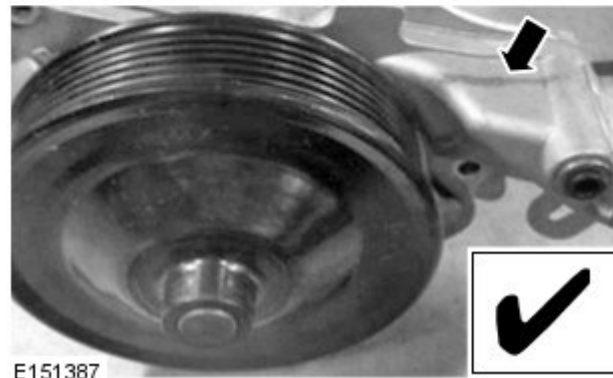
1. NOTE: Acceptable Coolant Pump Witness Marks

Check the coolant pump for witness marks before continuing:

- Note the severity of any witness marks on the repair order.
