Service Bulletin

Bulletin No.: 09-01-39-007C

Subject: Carpet Wet When A/C is On (Re-align A/C Drain Tube)

Models: 2014 Chevrolet SS
2011-2014 Chevrolet Caprice PPV
2008-2009 Pontiac G8

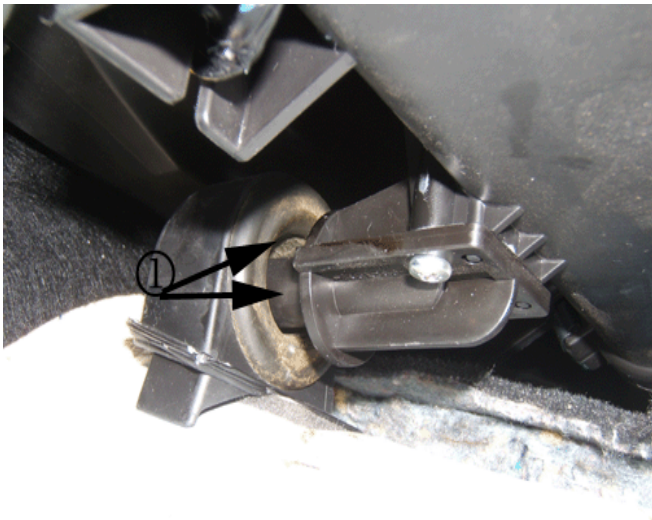
2321888

Example of a Collapsed A/C Drain Grommet

This condition may be caused by a collapsed A/C drain grommet (1), resulting in a wet carpet condition.
