NUMBER: 23-022-14 REV. A

Tailgate Retaining Strap Over Extends And Breaks

2012 - 2014 (JK) Wrangler

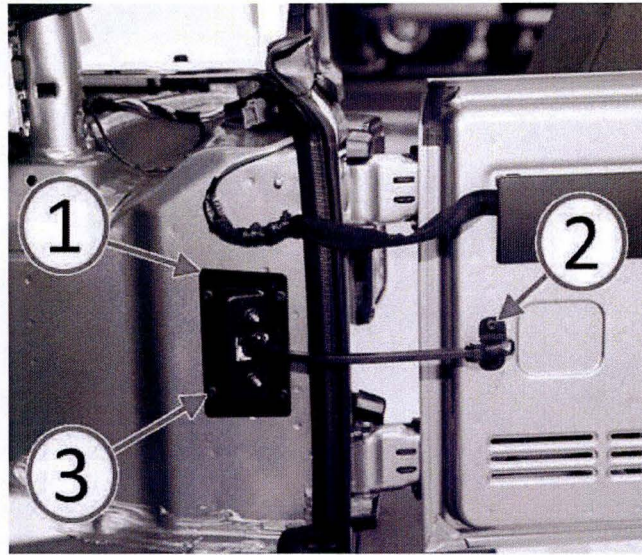
Fig. 6 Tailgate Retaining Strap

The tailgate retaining strap is damaged due to the tailgate hinge over extending. The retaining strap typically breaks at the body side of the retaining strap attachment. Tailgate hinge covers and/or tail lamp may also be damaged as a result of over extension.

-
8. Remove the two retaining strap to tailgate fasteners (2) and four retaining strap to body fasteners (3) then remove the tailgate retaining strap (1) from the vehicle (Fig. 6).

-
9. Install the new tailgate retaining strap (Fig. 6).
 10. Install the right rear quarter trim panel (Fig. 5). Refer to the detailed repair procedures available in: DealerConnect> TechCONNECT under: Service Info> 08 - Electrical> 8A - Audio/Video/Entertainment/Connectivity> SPEAKER> Installation> SUBWOOFER. Quarter trim panel without subwoofer requires a similar installation process but without speaker electrical connector.
 11. If the right side tail lamp was damaged due to tailgate hinge over extension, replace the tail lamp. Refer to the detailed repair procedures available in: DealerConnect> TechCONNECT under: Service Info> 08 - Electrical> 8L - Lamps and Lighting> Lamps> Lighting - Exterior> LAMP, Tail Stop Turn> Removal / Installation.
