**NUMBER:** 23-023-14

Metallic Rattle Noise From The Roof Headliner Area

2014 (DS) 1500 Pickup

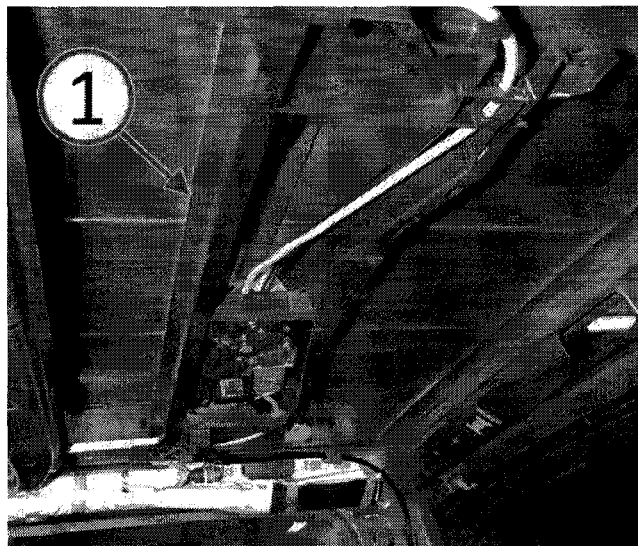
***Fig. 1 Roof Bow Inspection Location***

4. Lower the headliner and rest on the front seat headrests. Refer to the detailed service procedures available in DealerCONNECT> TechCONNECT under: Service Info> 23 - Body> Interior> HEADLINER> Removal.
5. Slide the sunroof shade forward, to expose the roof bow (1) (Fig. 1).

1 - Roof Bow

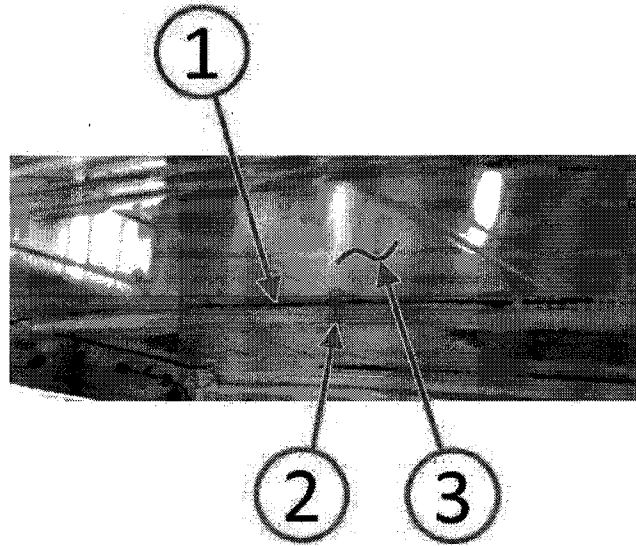
**Fig. 2 Roof Bow Bonding Inspection**

- 
6. Inspect for missing or separated anti-flutter adhesive foam (1) between the roof bow (2) and the roof sheet metal (3) (Fig. 2).

- 1 - Missing Or Separated Foam
- 2 - Roof Bow
- 3 - Roof Sheet Metal

8. Cover the interior components with a plastic cover before beginning the repair process.
9. Remove / scrape off the old anti-flutter adhesive foam that did not bond.

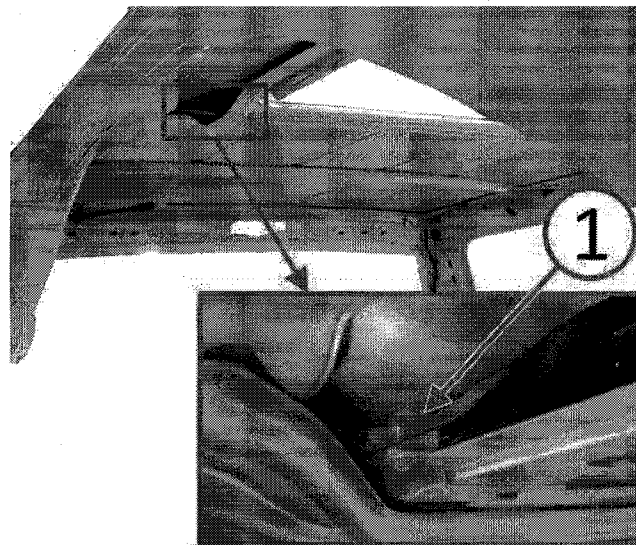
**Fig. 3 Sunroof Ring Bonding Inspection**

7. Inspect for missing or separated anti-flutter adhesive foam (1) between the sunroof opening reinforcing ring and the roof sheet metal in the right and left rear corners of the sunroof opening reinforcing ring (Fig. 3).

- 1 - Missing Or Separated Foam
-

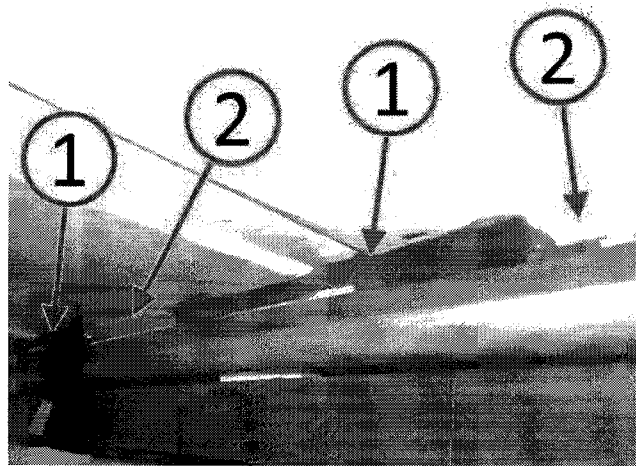
**Fig. 4 Urethane Application**

- 1 - Urethane Bead  
2 - Intensional Gap

**CAUTION: DO NOT APPLY A CONTINUOUS BEAD. Gaps in the urethane application are required to prevent distortion of the roof sheet metal panel as the urethane cures.**

10. Apply windshield urethane to the missing adhesive area in several 100 mm - 125 mm (4 in. - 5 in.) beads (1) with 75 mm (3 in.) gaps (2) (Fig. 4). Remove any excess urethane.
