NUMBER: 23-026-14 REV. A

Wind Noise At The Left And/Or Right Door

2014 (LC) Dodge Challenger

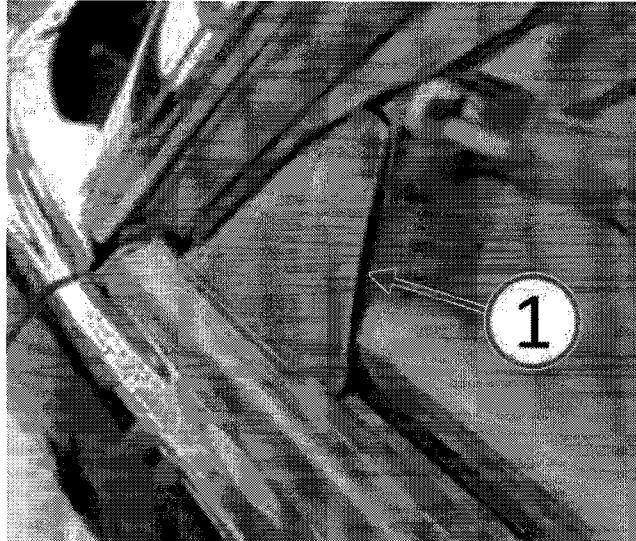
1. Raise the door window glass to the full up position.
2. Inspect both doors for a gap between the outer door mounted window seal flag and the door window glass (Fig. 1).

Fig. 1 Window Flag Gap Inspection

1 - Gap

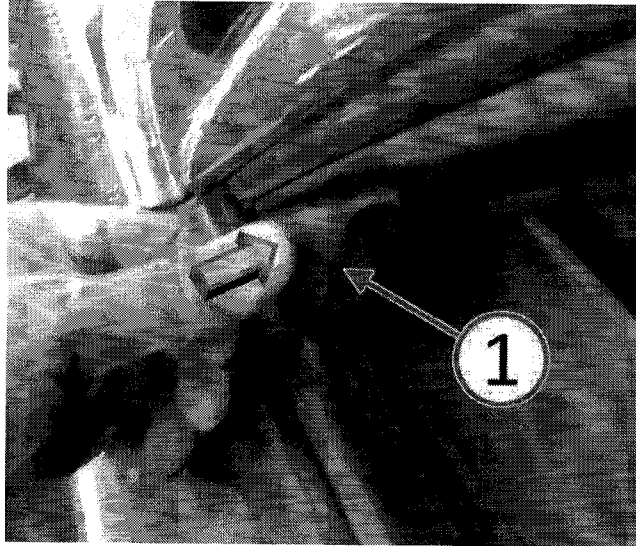
Fig. 2 Push In On The Window Flag

1 - Seal Flag

-
3. Is there a gap between the outer door mounted window seal flag and the door window glass?
 - a. YES>>> Continue with the Repair Procedure.
 - b. NO>>> This Bulletin does not apply. Further diagnosis is required.
 4. Fully lower the door window glass.
 5. Apply slight pressure to the outboard side of the seal flag. This will reposition the metal tab inside the seal flag moving the seal flag tighter to the glass surface (Fig. 2).

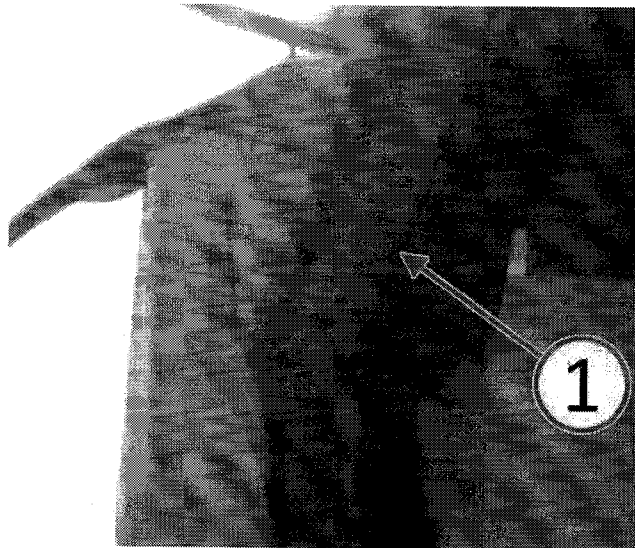
Fig. 3 Window Flag In Proper Position

1 - No Visible Gap

6. Raise the door window glass to the full up position.
7. Confirm that the gap has been eliminated between the outer door mounted window seal flag and the door window glass (Fig. 3).
