NUMBER: 23-034-14

SUBJECT:

Cowl Trim Panel Fastener Water Leak

2007 - 2014 (JK) Jeep Wrangler

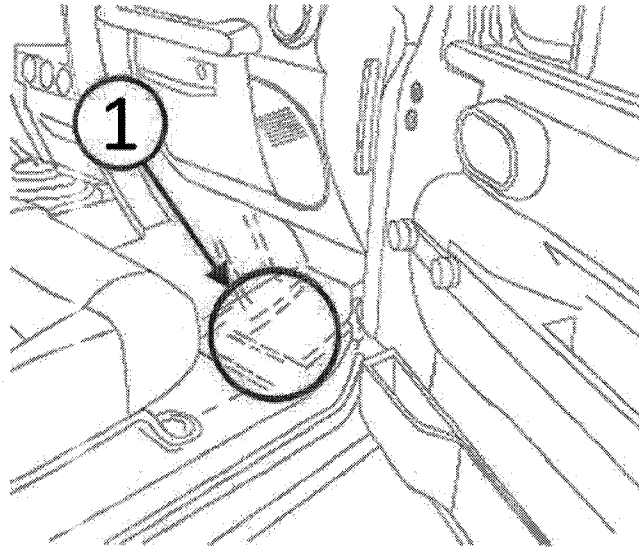
Fig. 1 Water In Foot Well

The customer may describe a water accumulation condition on the vehicle floor front foot well area.

1. Determine if water in the front floor foot well is coming from the cowl side trim panel fir tree fasteners. Refer to water leak diagnosis within the detailed service procedures available in DealerCONNECT> TechCONNECT under: Service Info> 23 - Body> Diagnosis and Testing (Fig. 1).
2. Was a water leak coming from the cowl side trim panel fir tree fasteners?

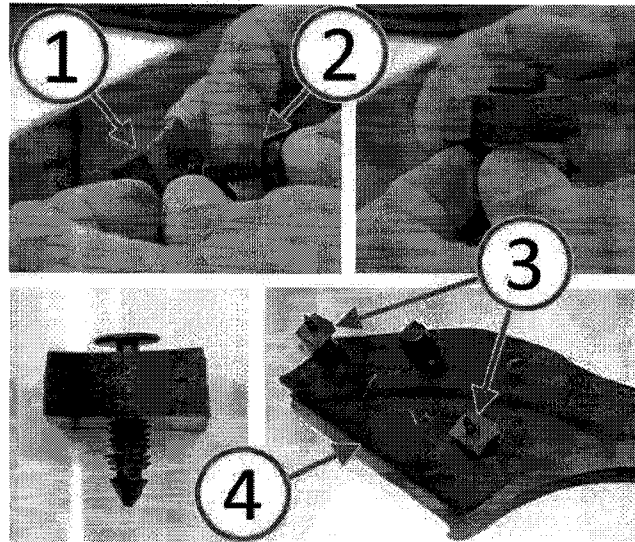
Fig. 4 Install Foam Seal

NOTE: Sticky side of the foam seal MUST face toward the fir tree fastener head. If reversed, it may create a water leak.

9. Install the created foam seal (1) onto the fir tree fastener (2) with the sticky side facing toward the fir tree fastener head (Fig. 4).

10. Install both fir tree fasteners with foam seal (3) onto the cowl trim panel (4) (Fig. 4).
